FINAL REPORT
GRAND CANAL ECOLOGICAL AND PUBLIC HEALTH ASSESSMENT
Report Tasks 1-6

GRAND CANAL ECOLOGICAL AND PUBLIC HEALTH ASSESSMENT

REPORT TASKS 1-6

SUFFOLK COUNTY DEPARTMENT OF HEALTH SERVICES

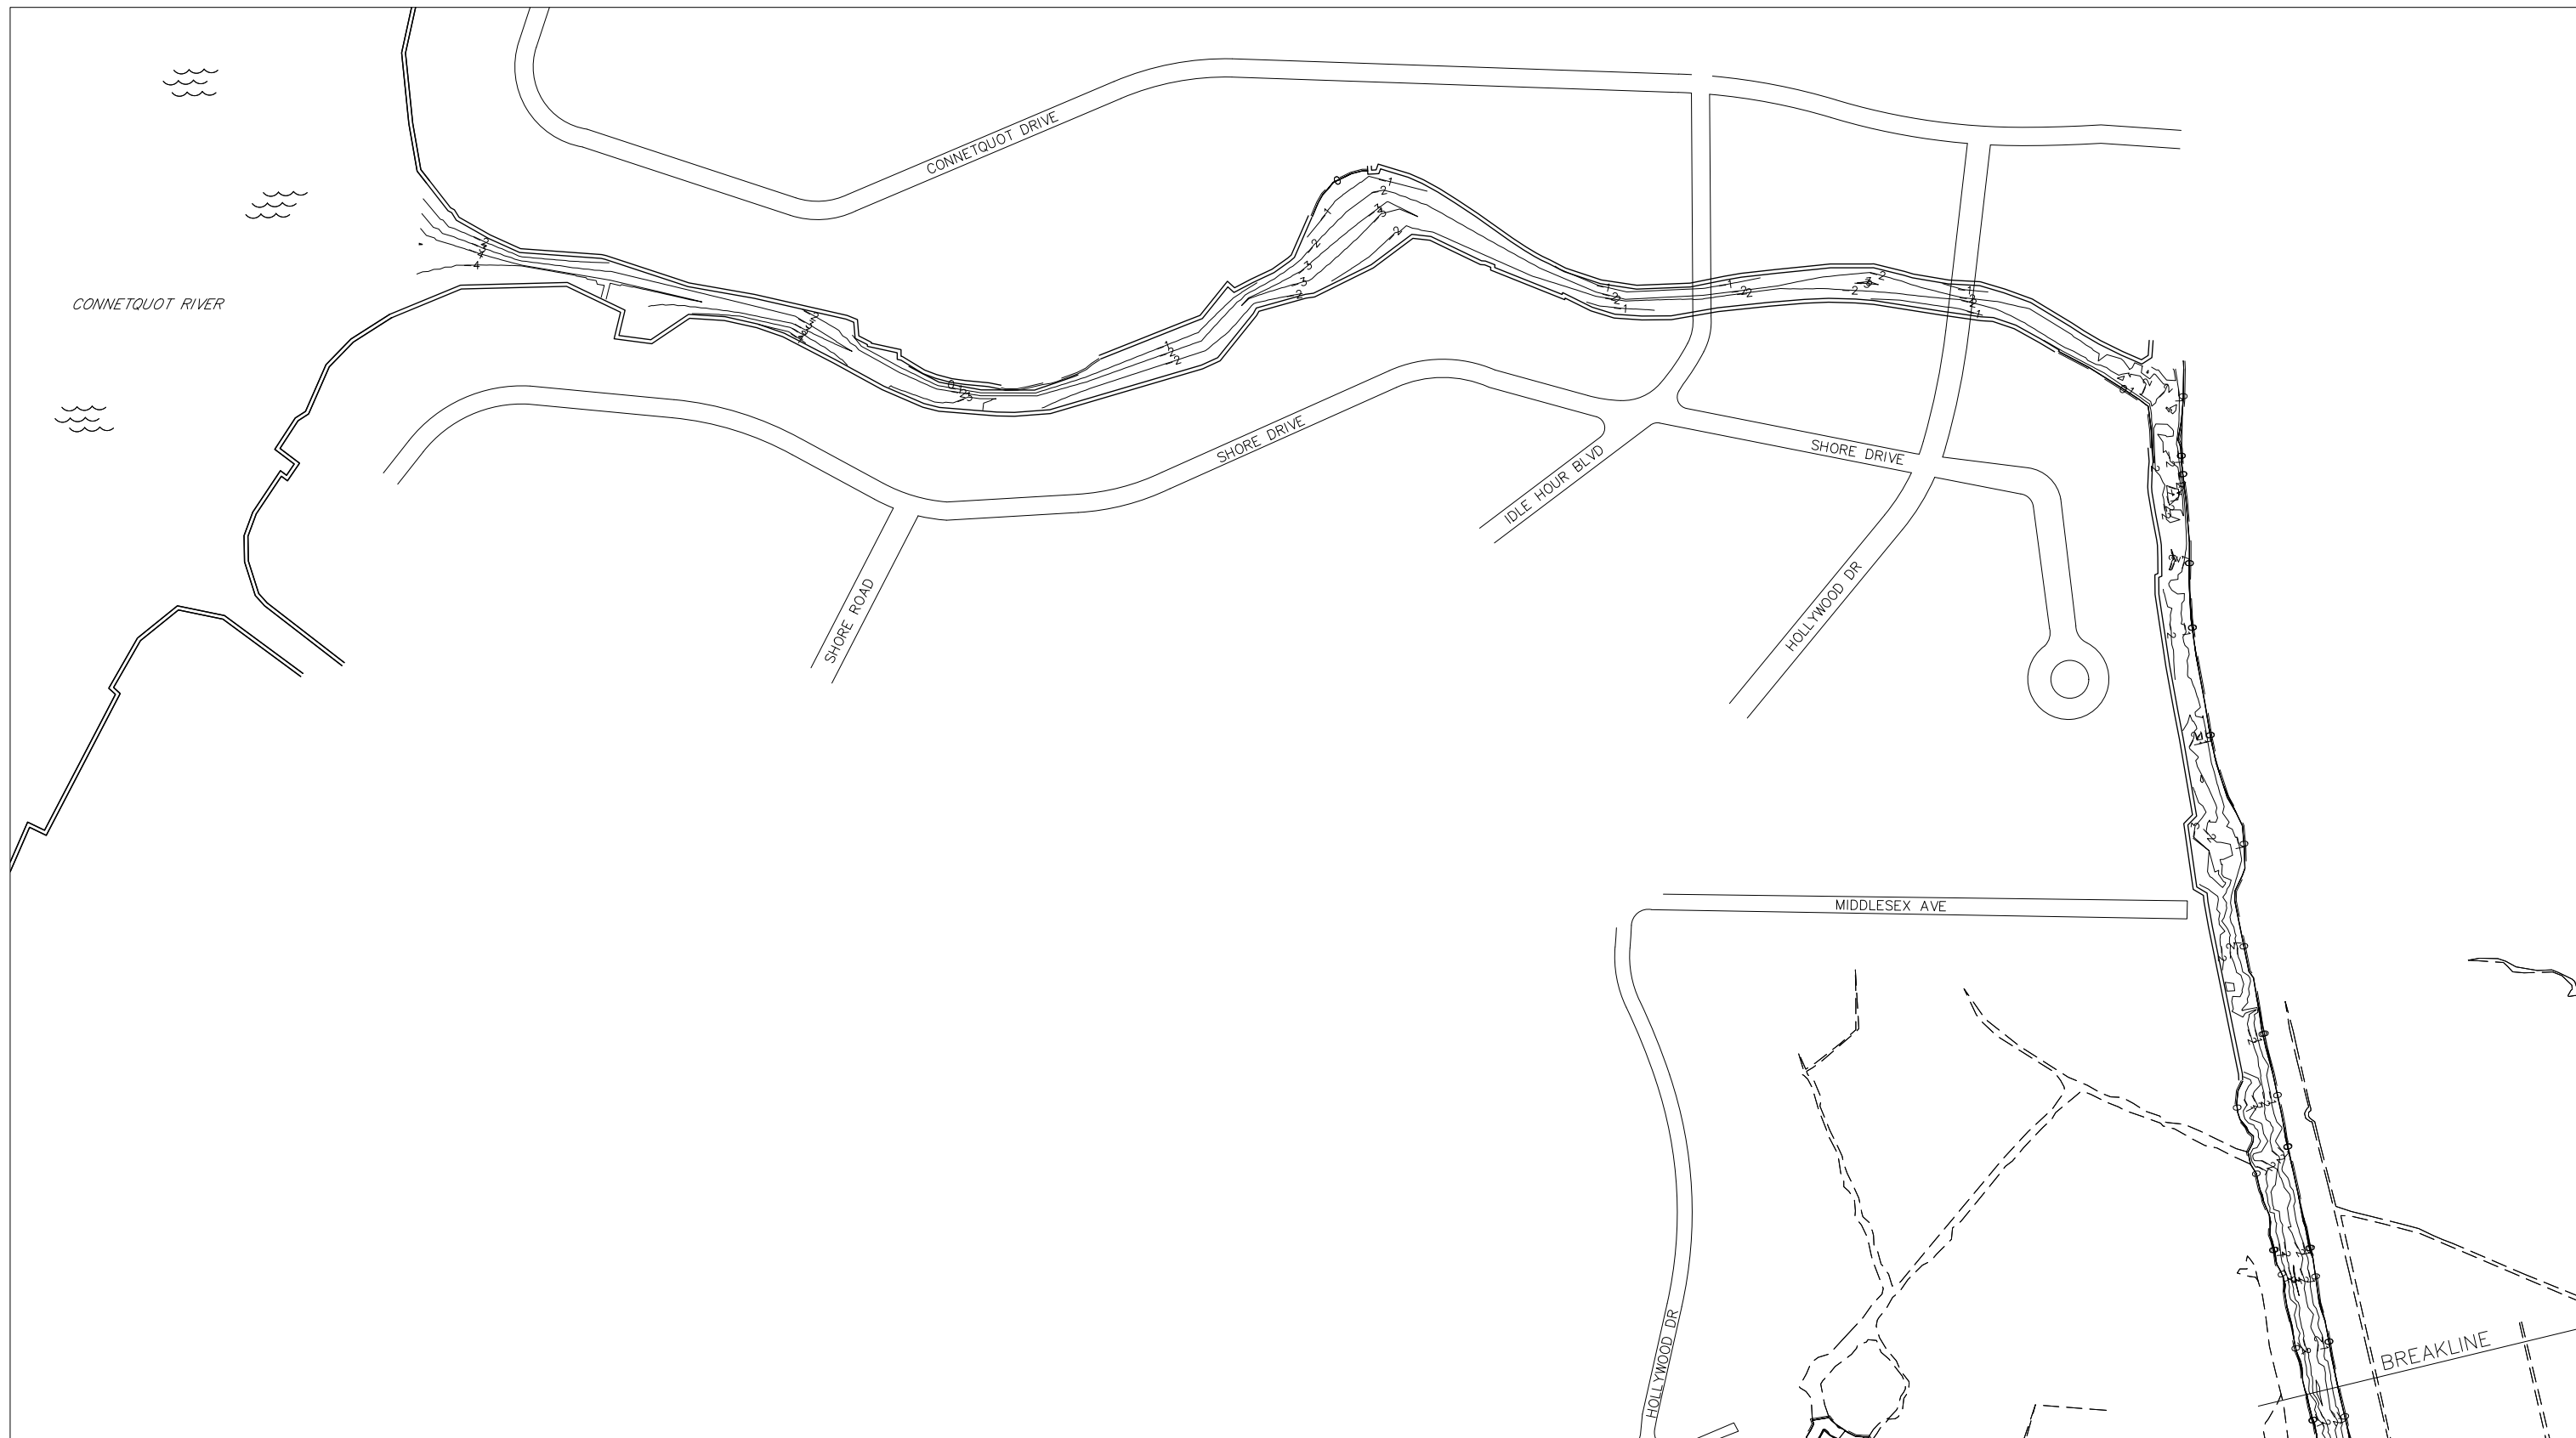
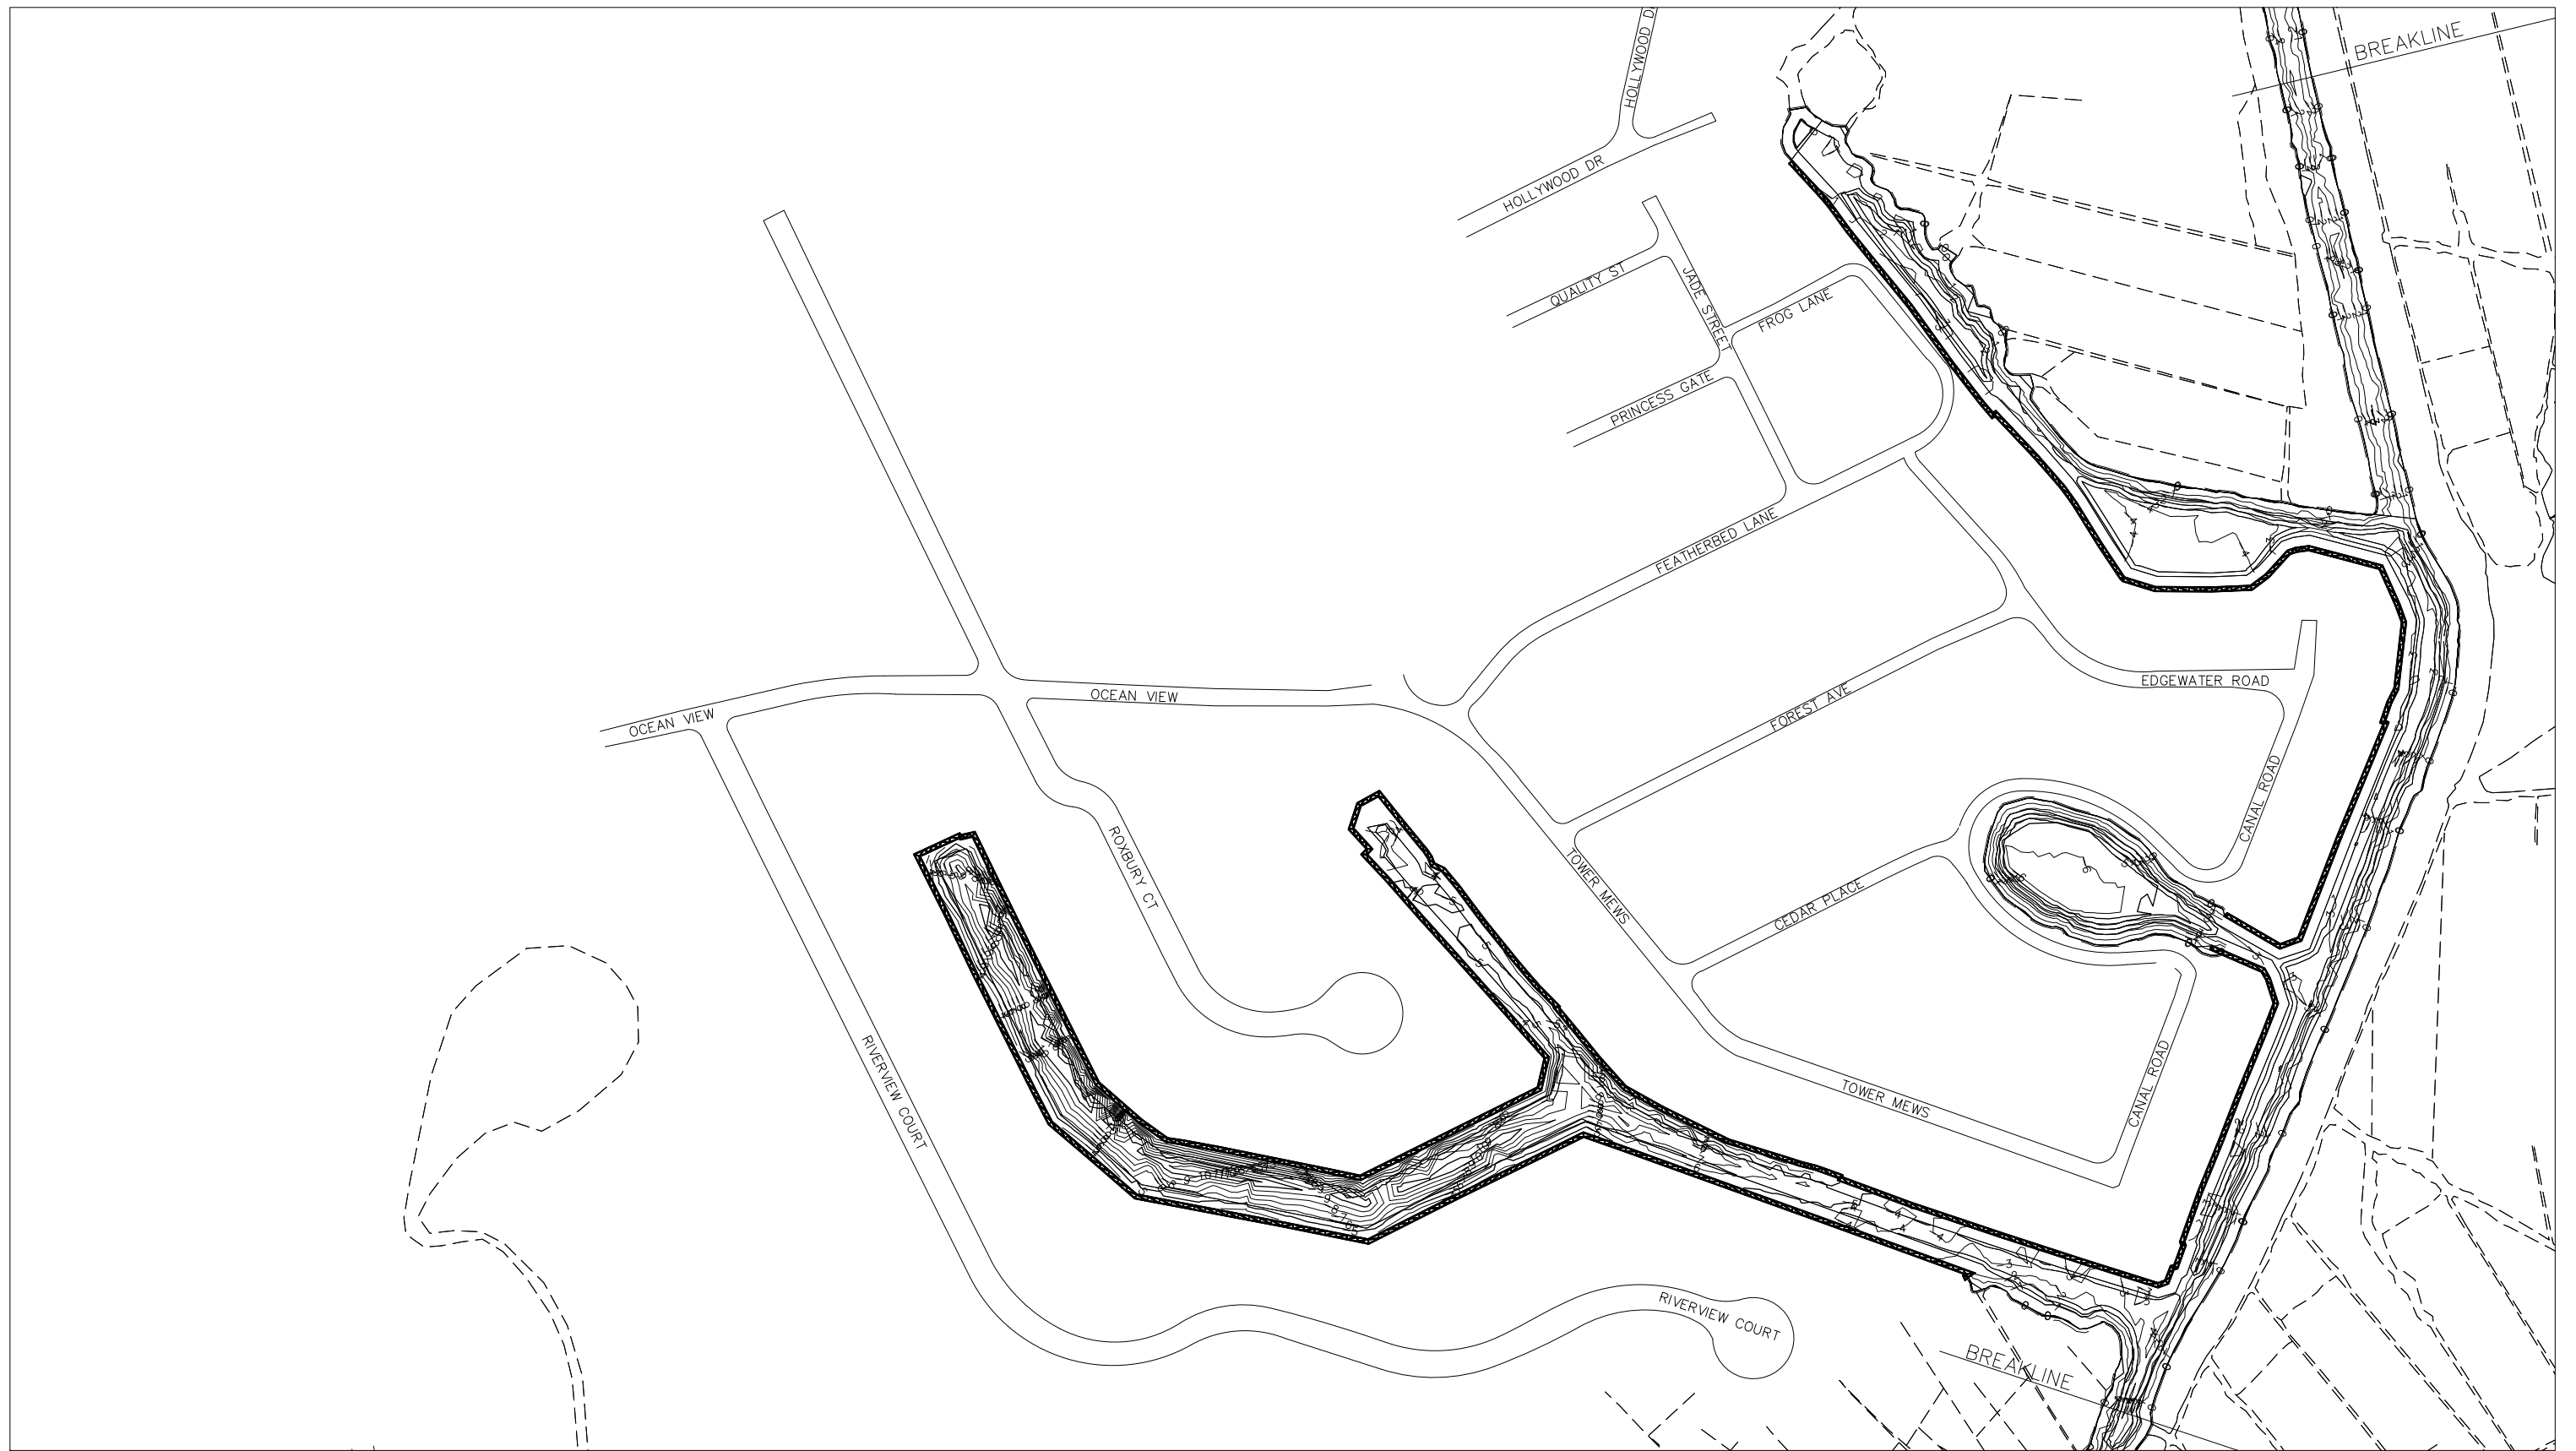
MAP 3

A total of 845 bathymetric data points were collected during the bathymetric survey event. Bathymetric maps were created from these data, as shown in Map 3. Mapping was based on mean low water (MLW) as dictated by NGVD29 and NAD83 State Plan Coordinates, New York Long Island Zone.

The main section of the Grand Canal was found to vary in width from approximately 75-feet at its widest point (just south of the Shore Drive Bridge) to approximately 30-feet at its narrowest point (just east of the Idle Hour Boulevard Bridge). The main channel of the canal varies in depth from the deepest point of approximately five feet below mean low water (MLW) near the southern entrance to approximately two feet below MLW at its shallowest along the northern transect of the canal (Map 3). The entrance of the canal at the Snapper Inn is actually narrower than the main section of the canal, with a width of about 25 feet.

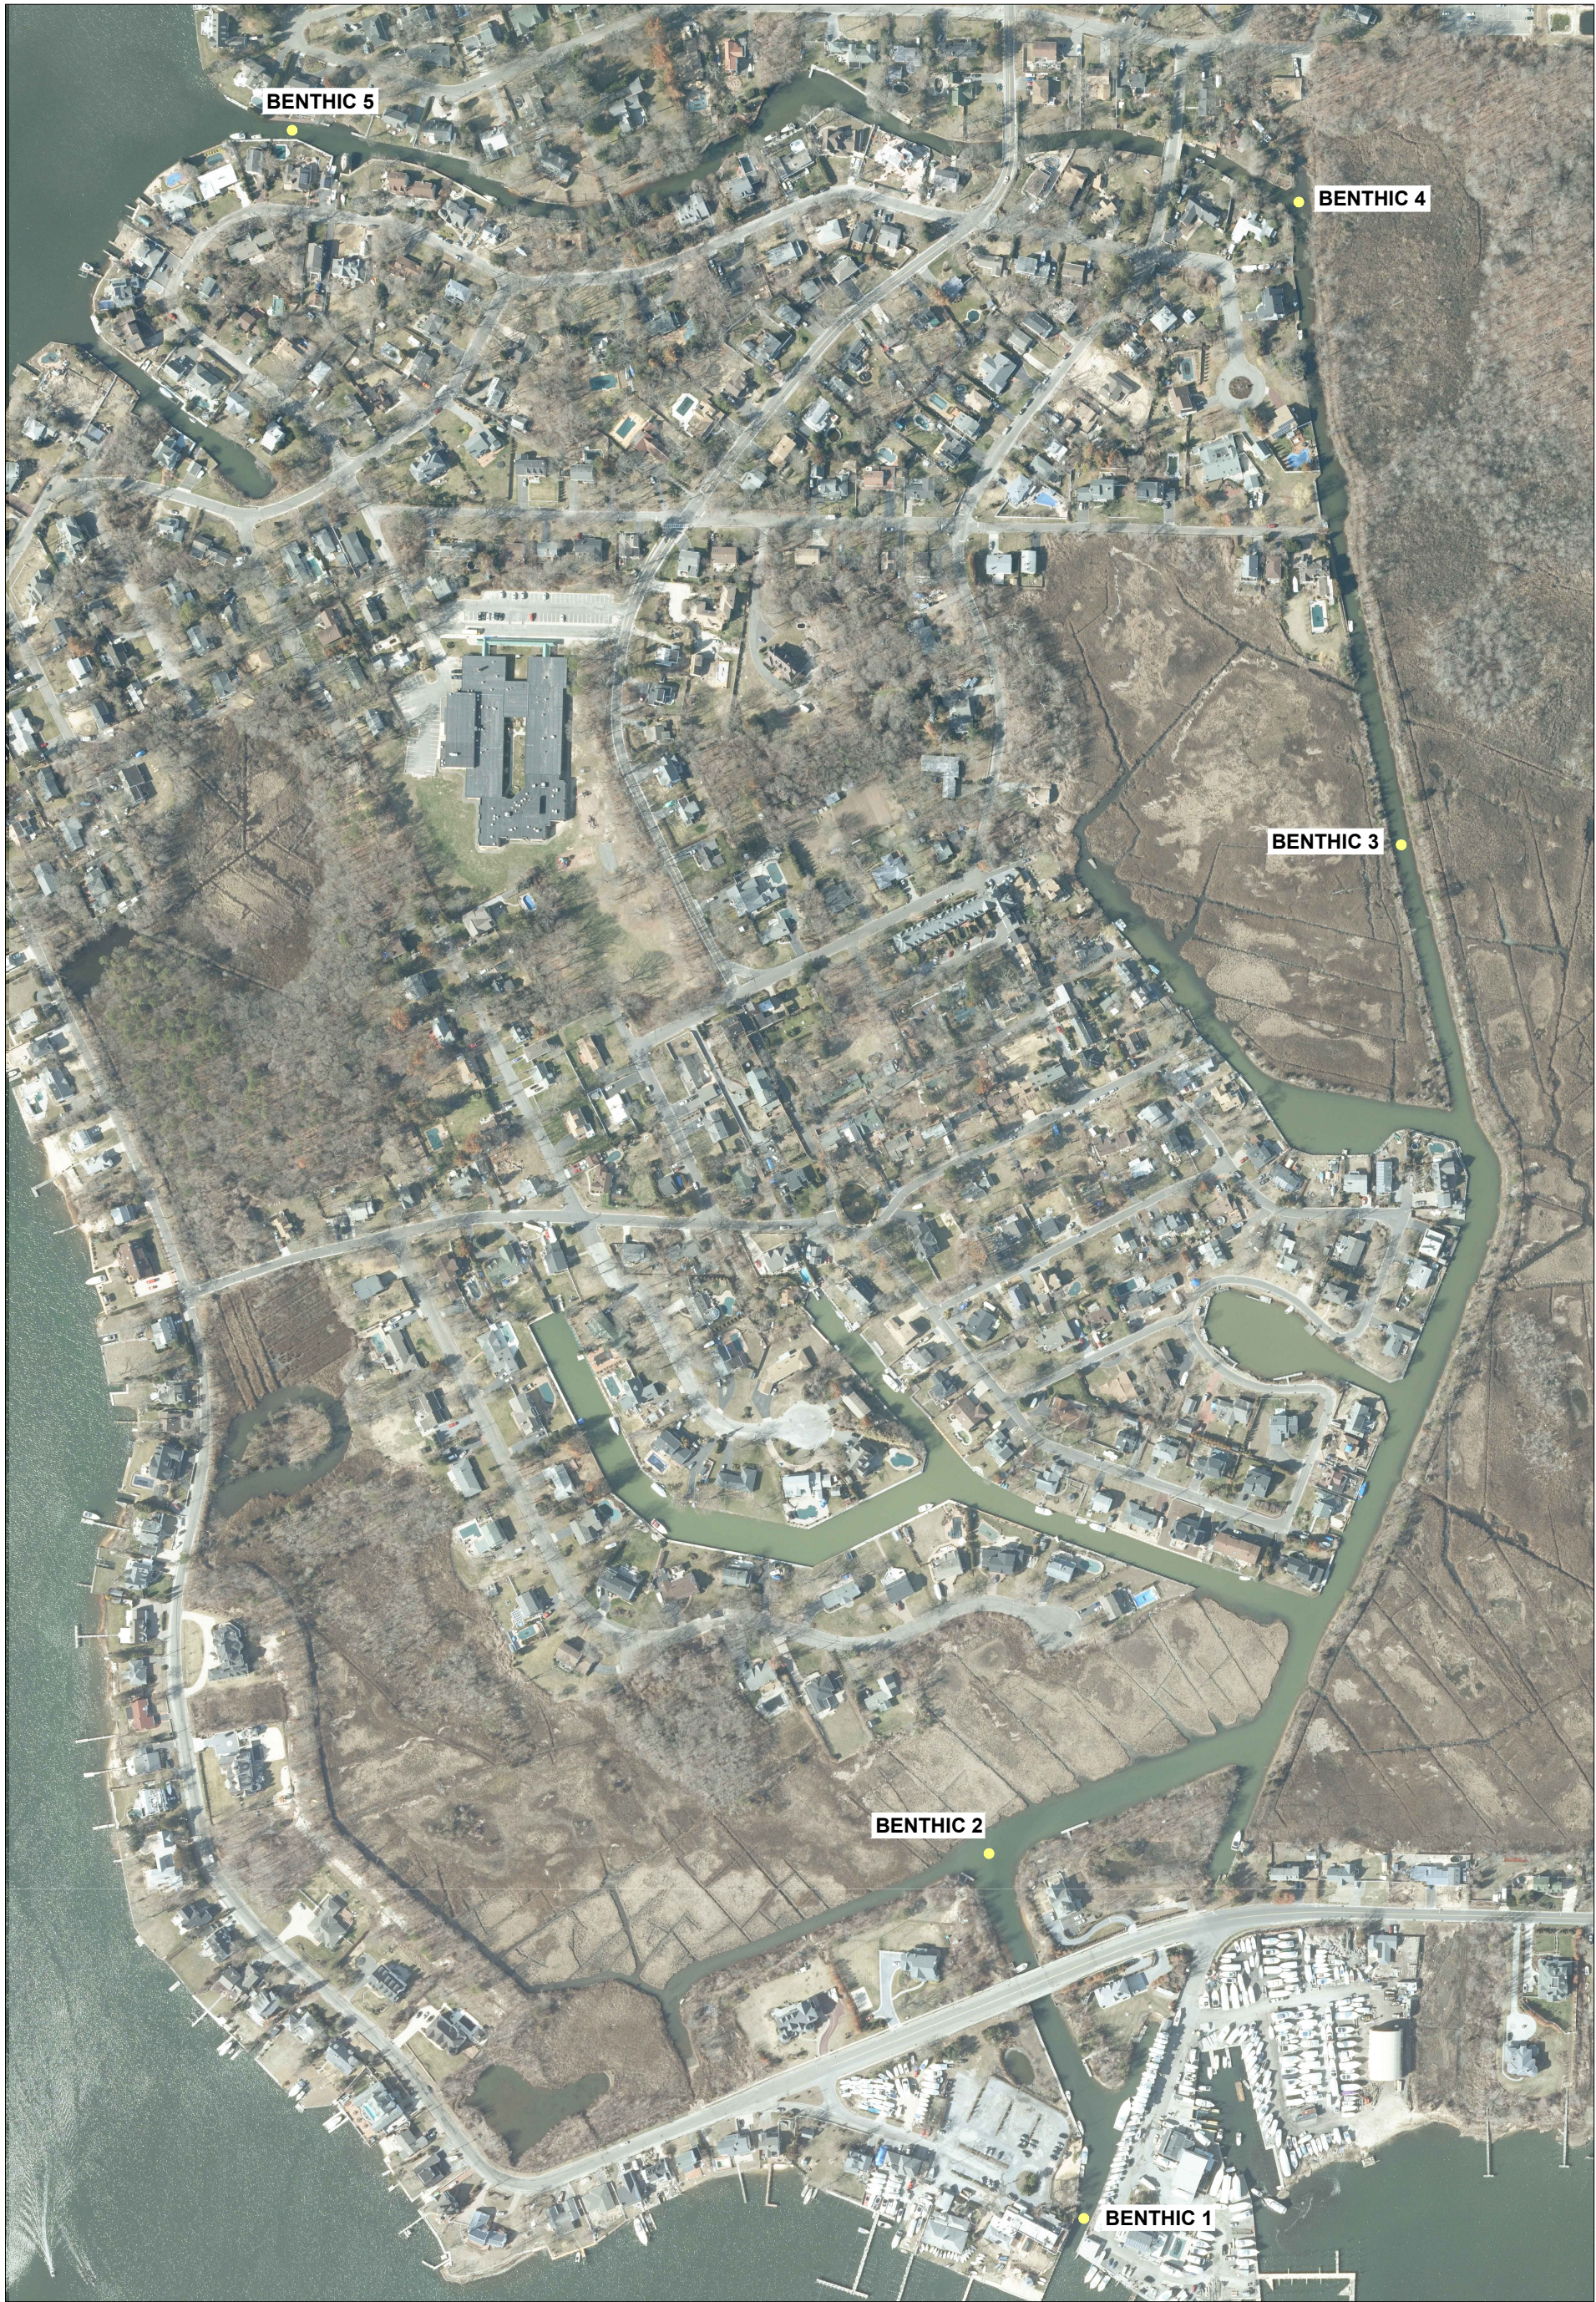
MAP 4

Spring benthic samples were collected on June 4, 2015 from a total of five sites with two replicates at each site (totaling ten samples) (Map 4). A total of 222 benthic organisms were collected from all ten samples. A total of ten species were identified during the spring event. *Ampelisca spp.* was the most abundant species with 127 benthic organisms found in six of the ten samples collected. *Myodocopido spp.* was the next most abundant species with 31 organisms found in two of the ten samples. Replicate 1a had the highest species richness with a total eight different organisms identified. Table 3 depicts the spring benthic organism abundance by species and sample.

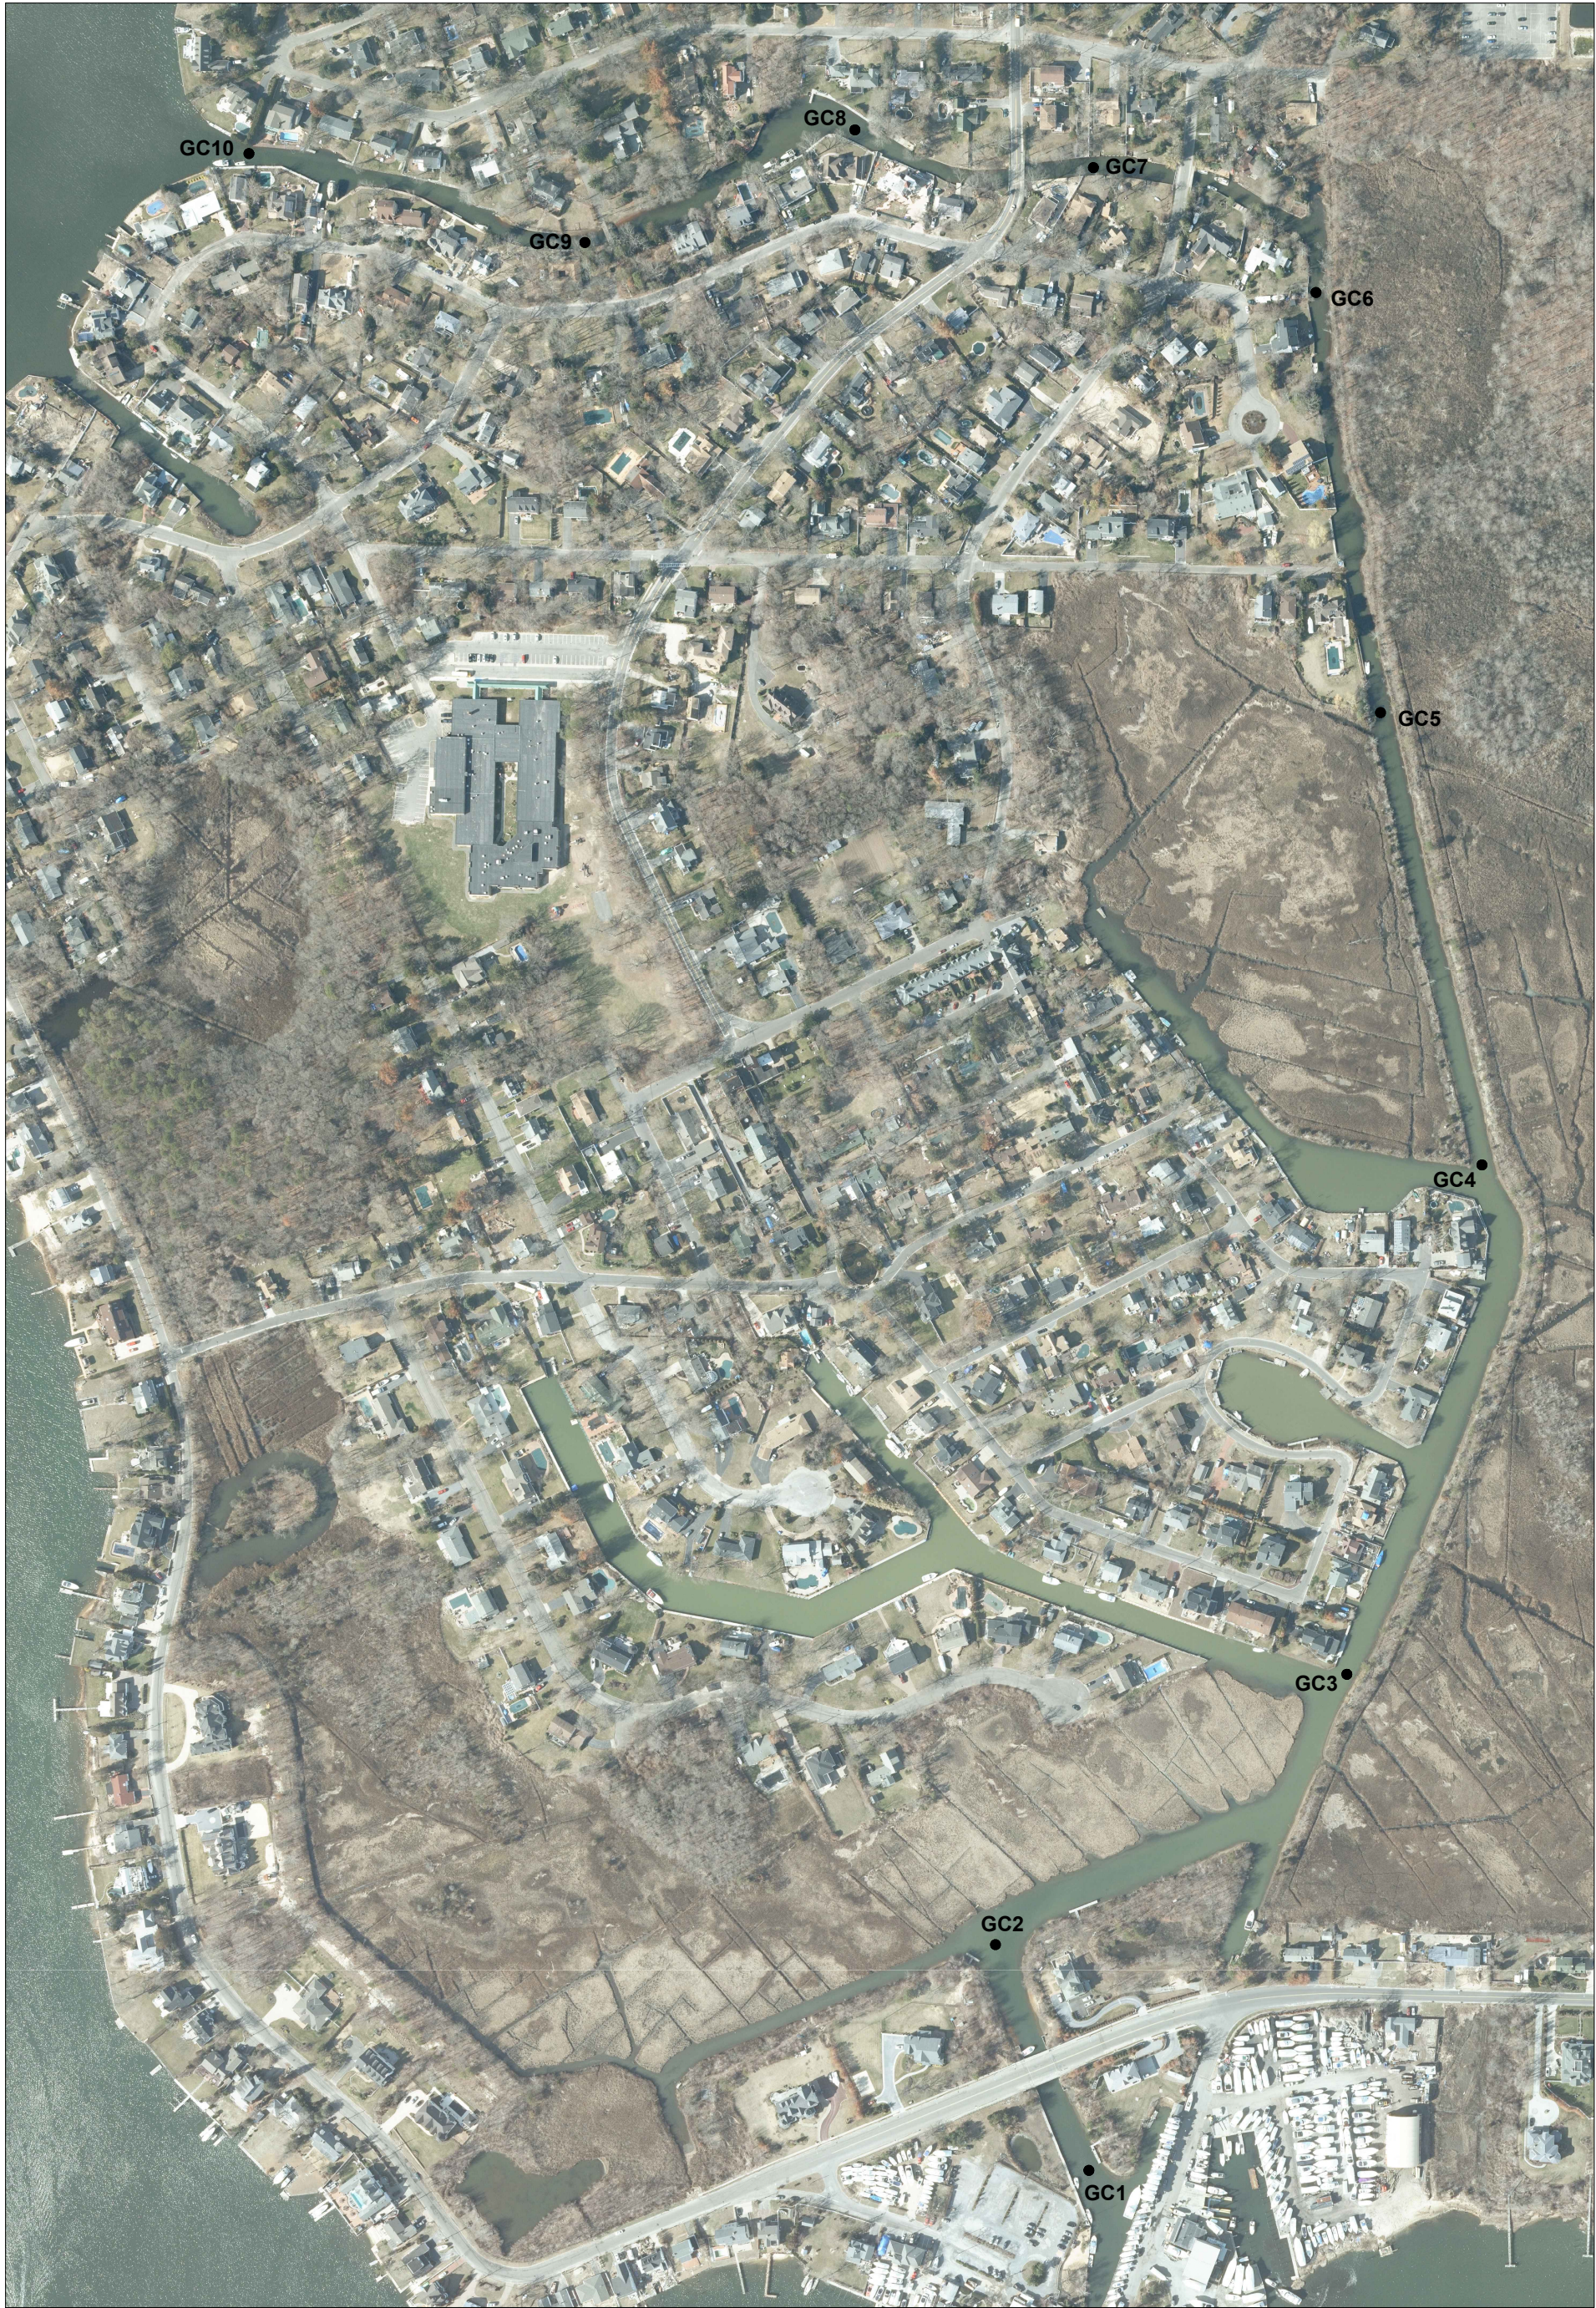
MAP 5

After collection, the sediment samples were immediately labeled and preserved on ice; the first two sub-samples were analyzed (20 samples) and the third (10 samples) was archived for possible further analysis, depending on initial testing results. Samples were analyzed for grain size distribution and Total Organic Carbon (TOC) content.

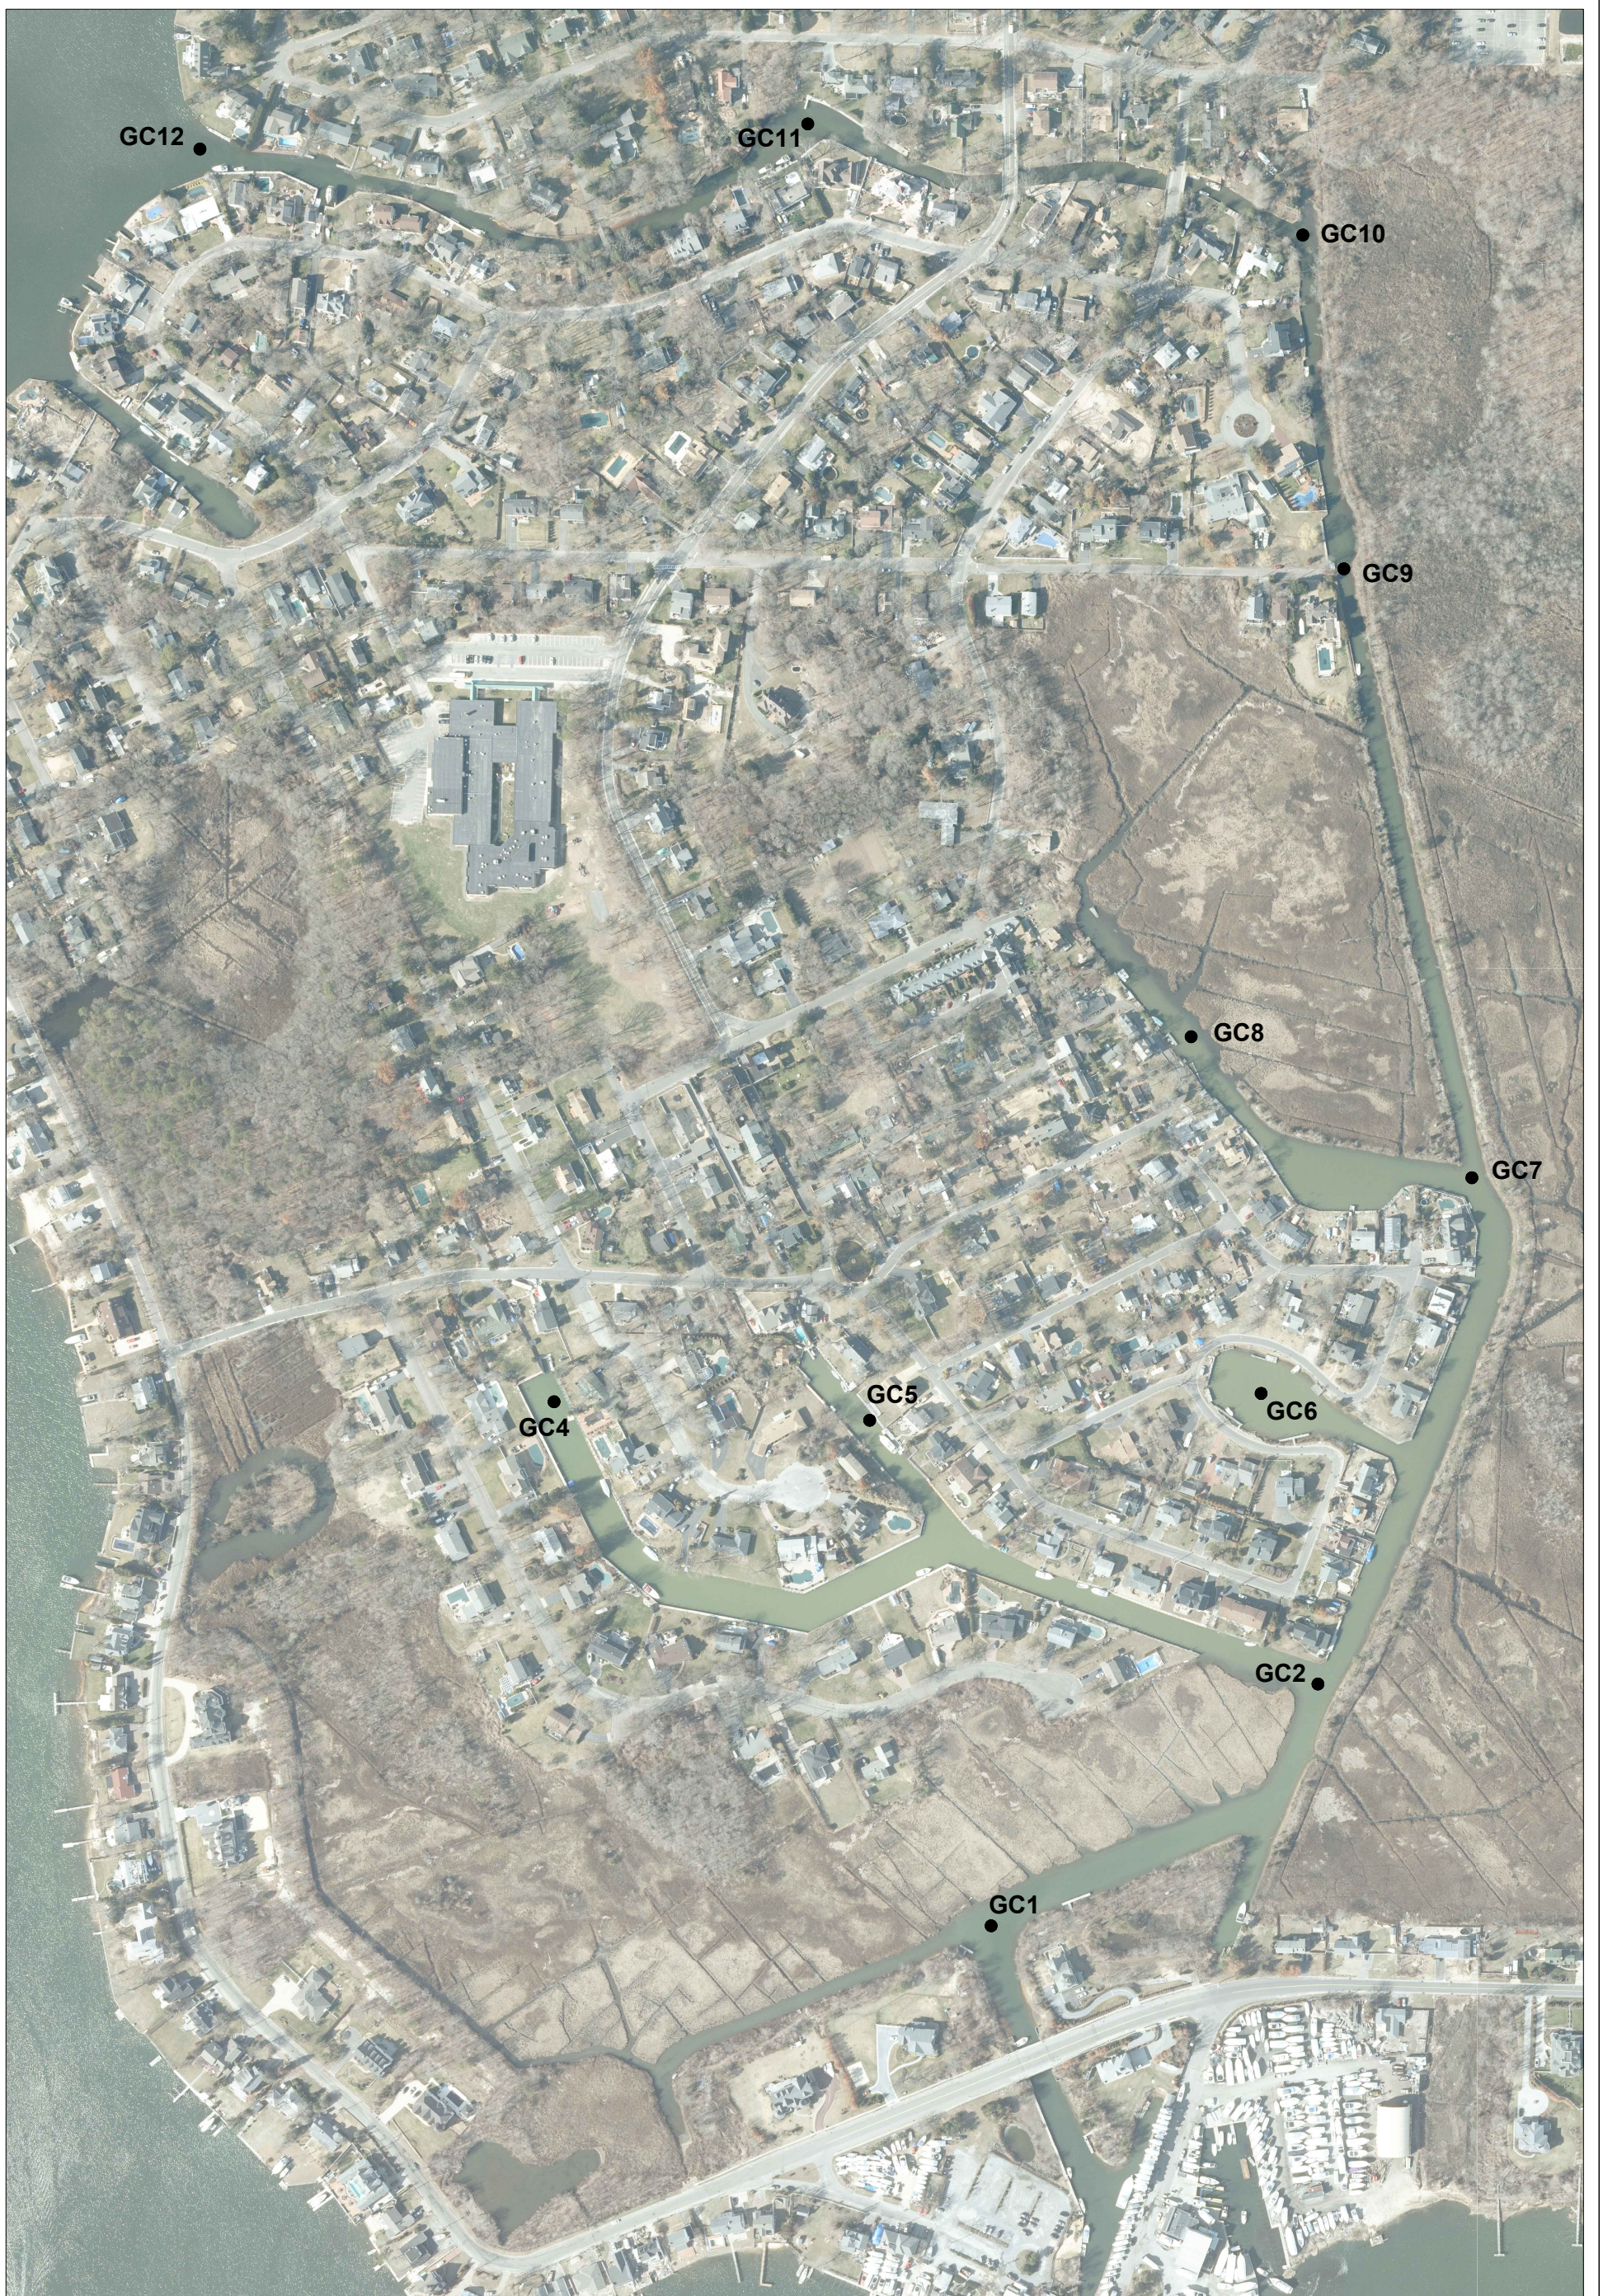
MAP 6

A total of 11 sample sites were selected throughout the canal for tidal stage surface water quality sampling; GPS coordinates for each sample location were recorded and sample locations are shown in Map 6. At each of the 11 sites, water samples were collected during each of four tidal stages, resulting in a total of 44 water samples per sampling event (for a total of 88 samples over both sampling days). The sampling methodology used was based on Suffolk County's sampling protocol. The water samples were immediately labeled and preserved on ice after collection.
