FINAL REPORT
GRAND CANAL ECOLOGICAL AND PUBLIC HEALTH ASSESSMENT
Report Tasks 1-6

GRAND CANAL ECOLOGICAL AND PUBLIC HEALTH ASSESSMENT

REPORT TASKS 1-6

SUFFOLK COUNTY DEPARTMENT OF HEALTH SERVICES

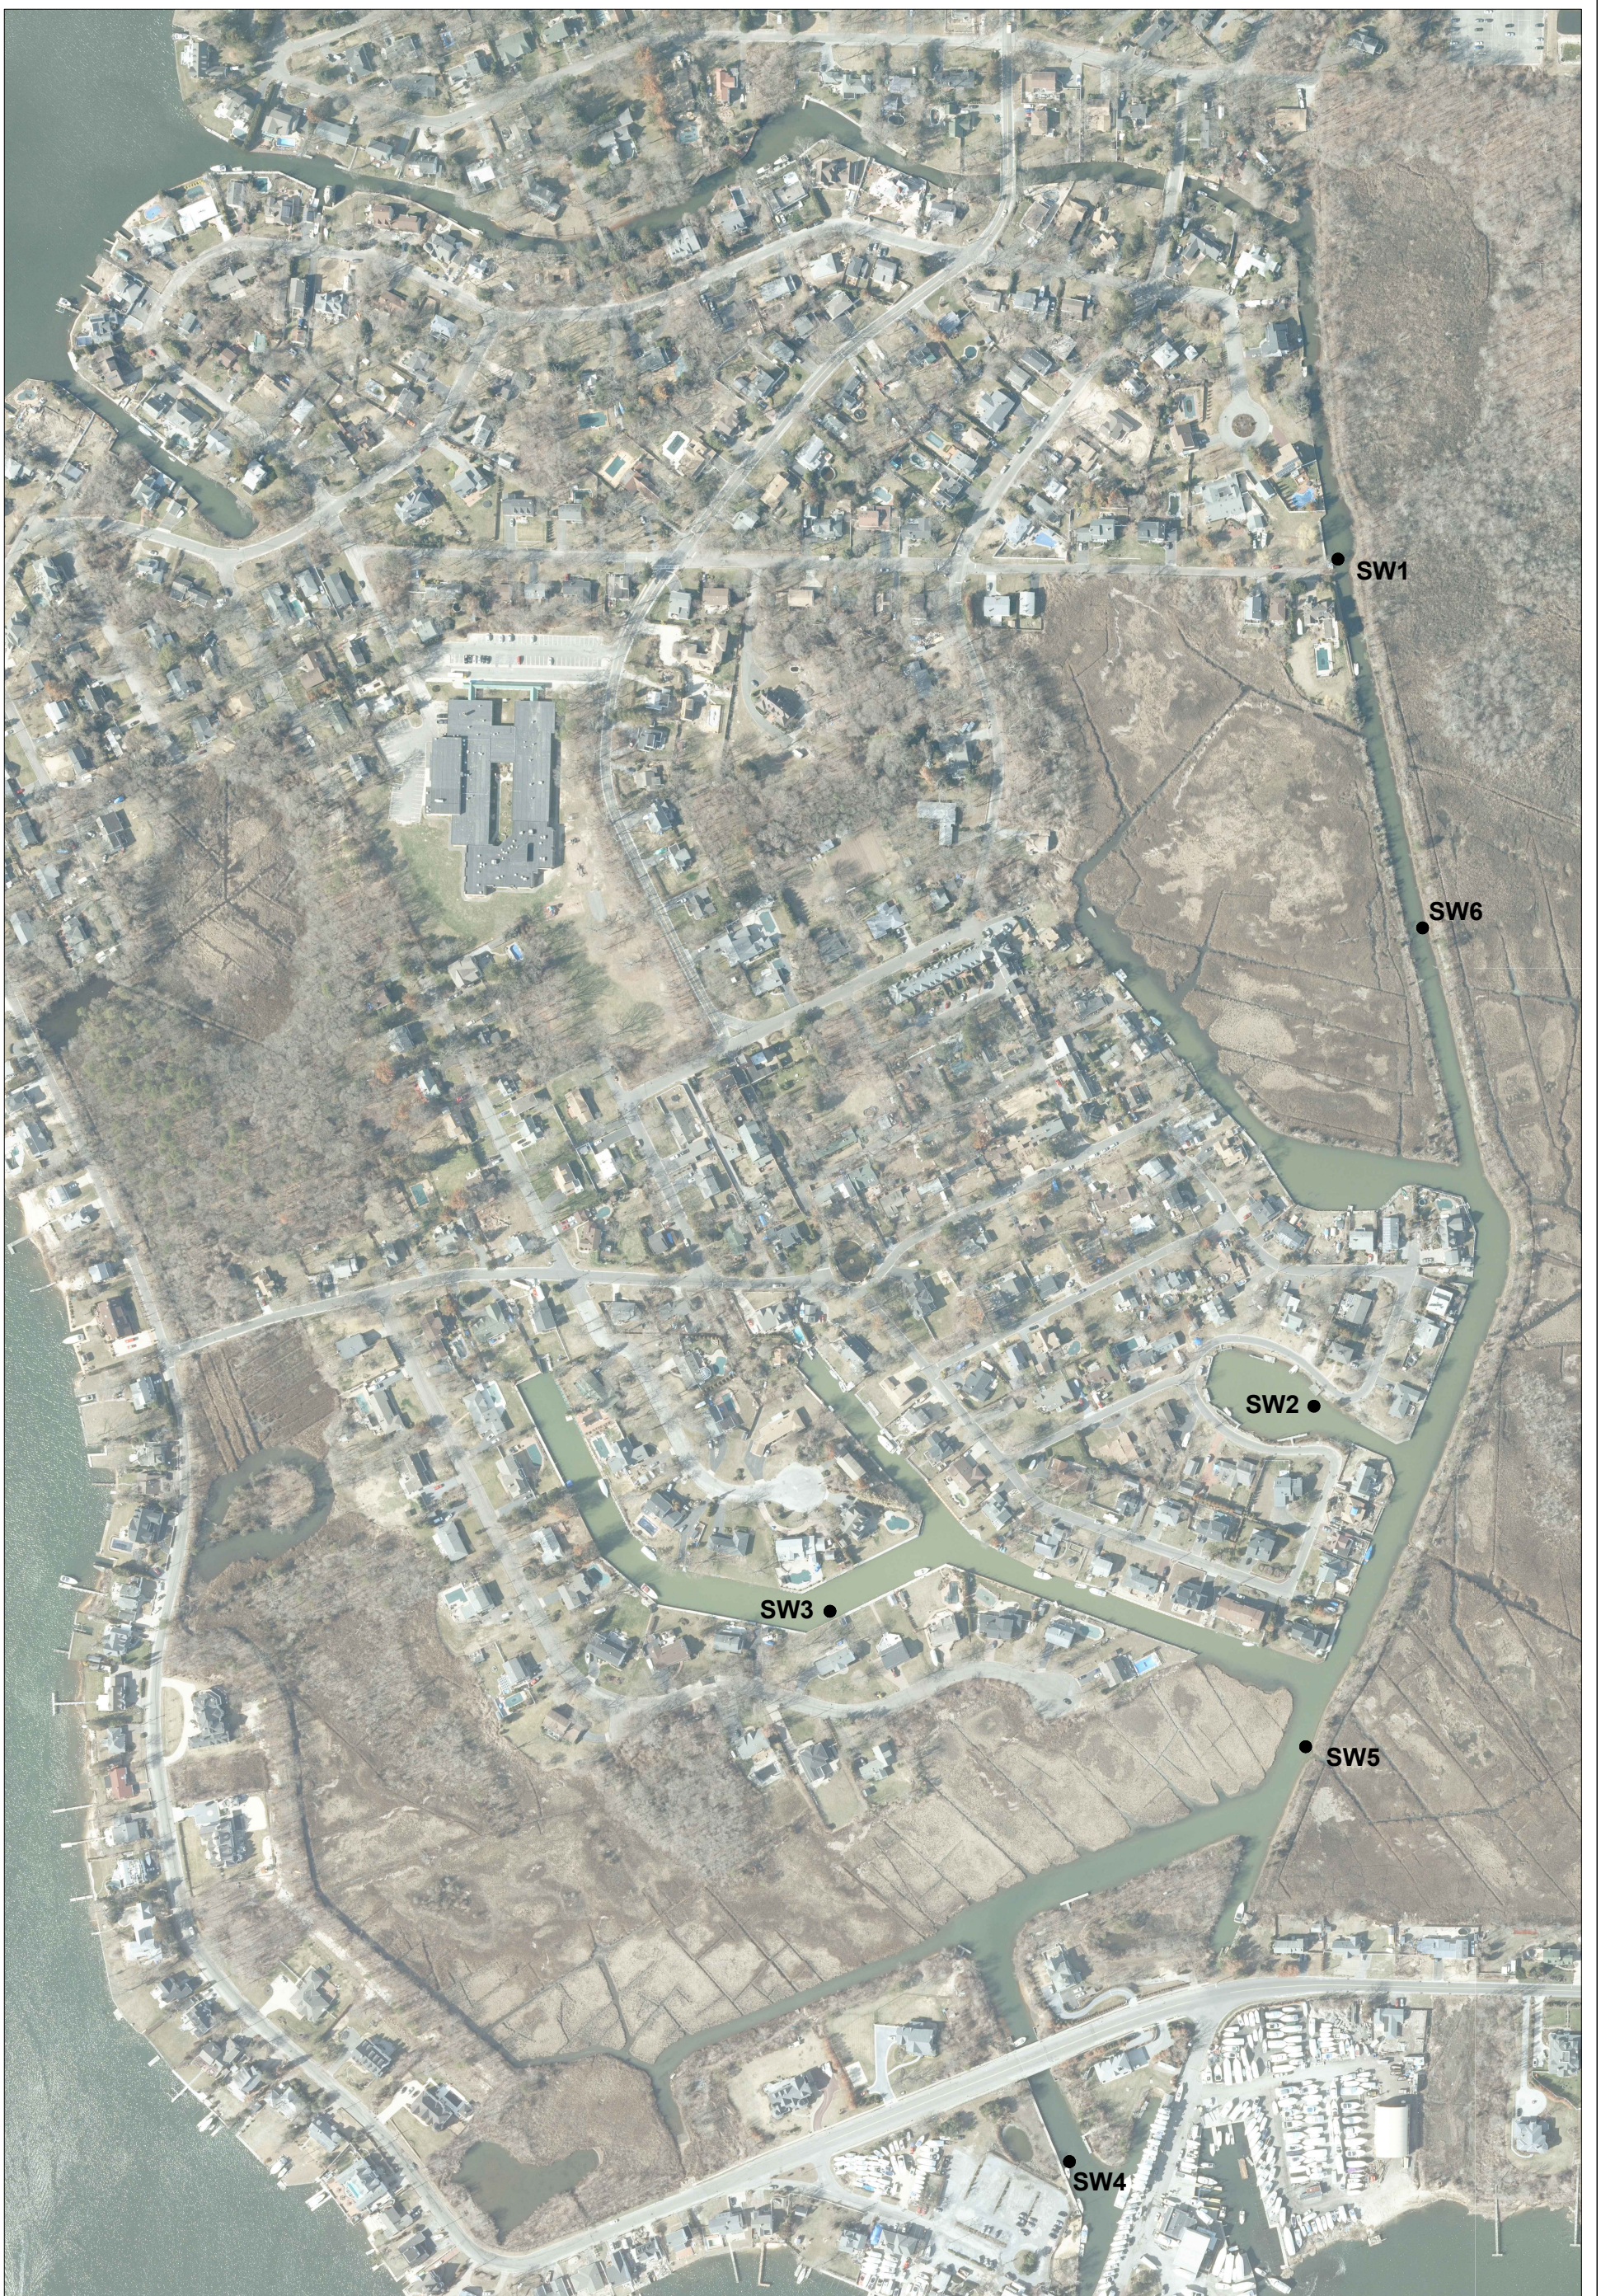
MAP 8

To provide baseline data, CA performed sampling for the dry event on September 3, 2015. The same sampling sites were used as those during the wet event (Map 8). This date was selected for sampling as it followed a period of dry weather (at least 72 hours without rainfall). This dry event allows for an understanding of existing environmental conditions in the Grand Canal prior to any potential contamination by storm water runoff.

Sample areas for the storm water runoff study were selected based on the presence of areas with direct outfall and/or drainage, as indicated in the field inventory of the canal. A total of six sample sites were selected throughout the canal for stormwater runoff water quality sampling; GPS coordinates for each sample location were recorded and sampling locations are shown on Map 8. At each site, water samples were collected, resulting in a total of six water samples per sampling event (for a total of 12 samples over both sampling days). The sampling methodology was based on that Suffolk County's sampling protocol. The water samples were immediately labeled and preserved on ice after collection.
