***Investigation of Potential Impacts to
Groundwater From Contaminated Fill at
Roberto Clemente Park, Brentwood, N.Y.***

July 10, 2015

Figure 1 – Roberto Clemente Park, Brentwood NY

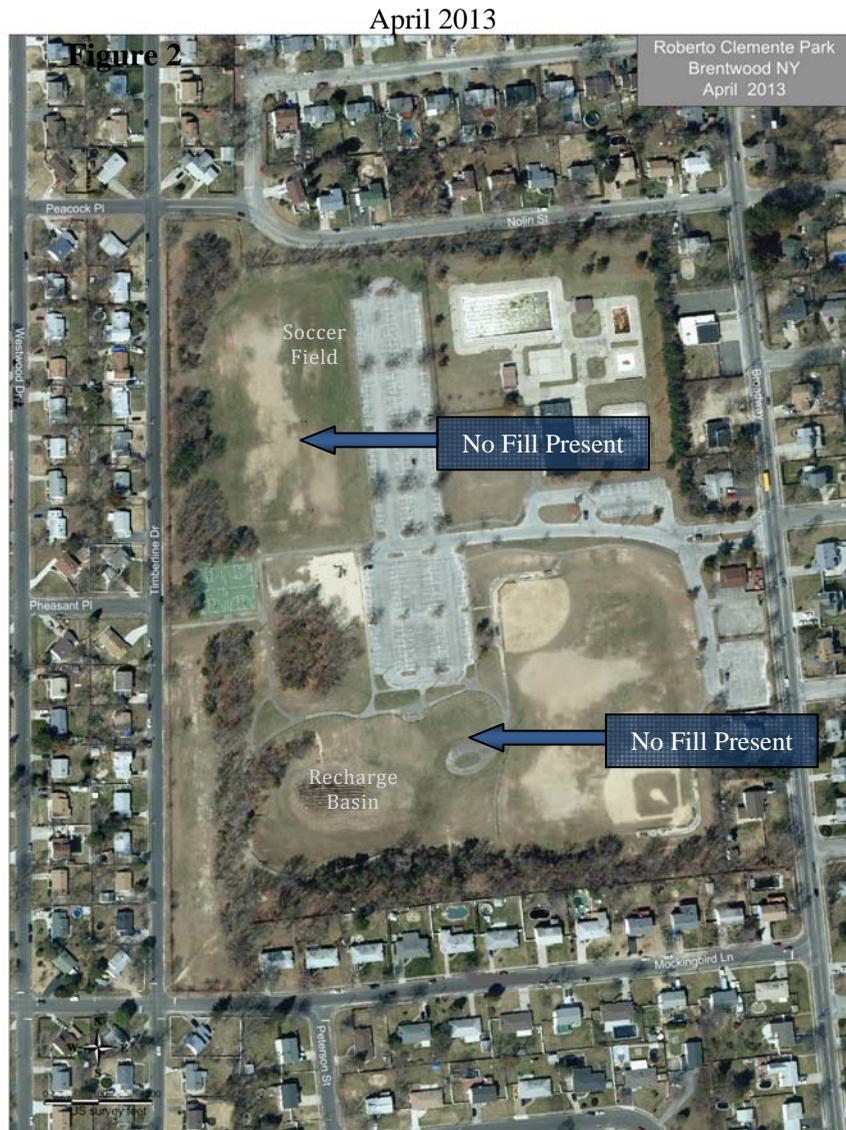
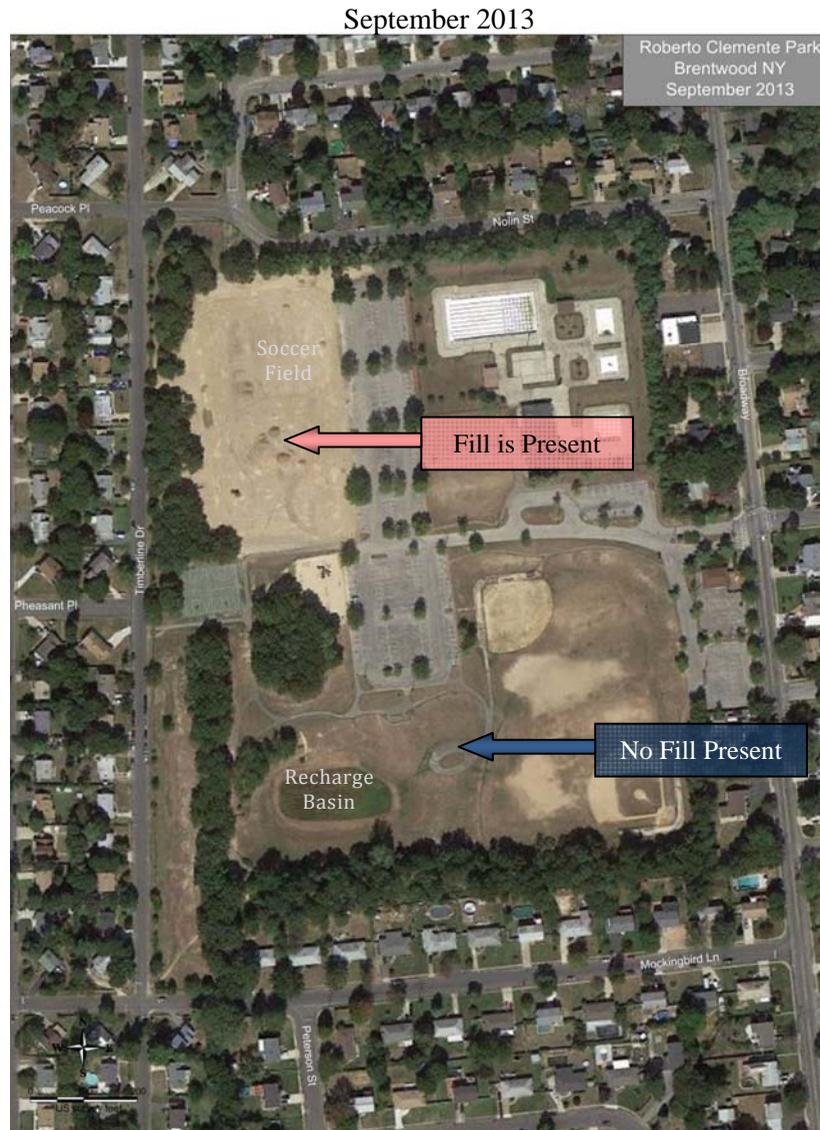
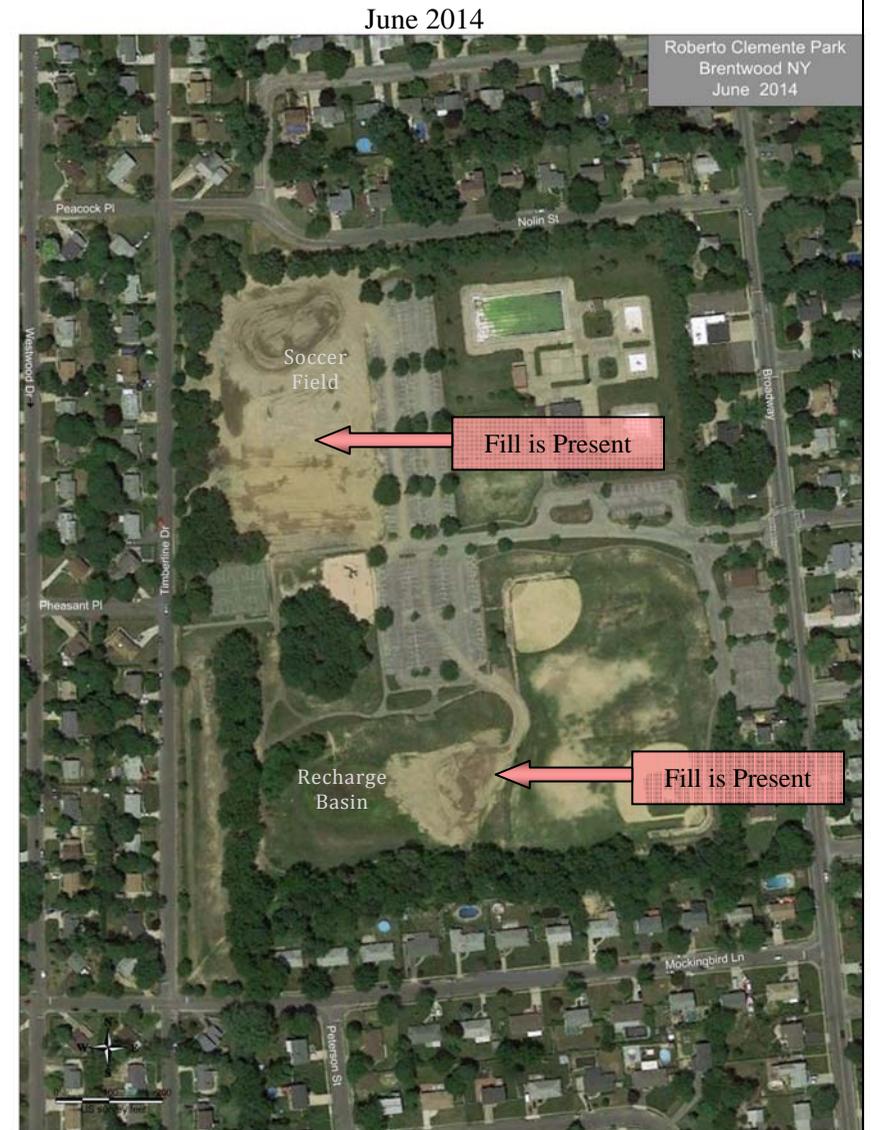
The aerial photographs in Figure 1 indicate that the illegally dumped fill was placed on the soccer field between April and September of 2013, and was placed in the recharge basin between September of 2013 and June of 2014. The Suffolk County District Attorney's office contracted with Enviroscience Consultants, Inc. to determine the extent of the fill and to test composite samples of the soil to determine contaminant concentrations. The Enviroscience results indicated that the soil contained elevated concentrations of metals (including lead, zinc, chromium, and copper), pesticides (including DDE, DDT, and dieldrin), various semi-volatile organic compounds, as well as a detection of the volatile organic compound (VOC) tetrachloroethene. Enviroscience estimated that 45,000 tons of illegal fill was dumped on the soccer field, and 5,000 tons in the recharge basin. They also reported that the fill was found to be up to approximately 9 feet in depth.

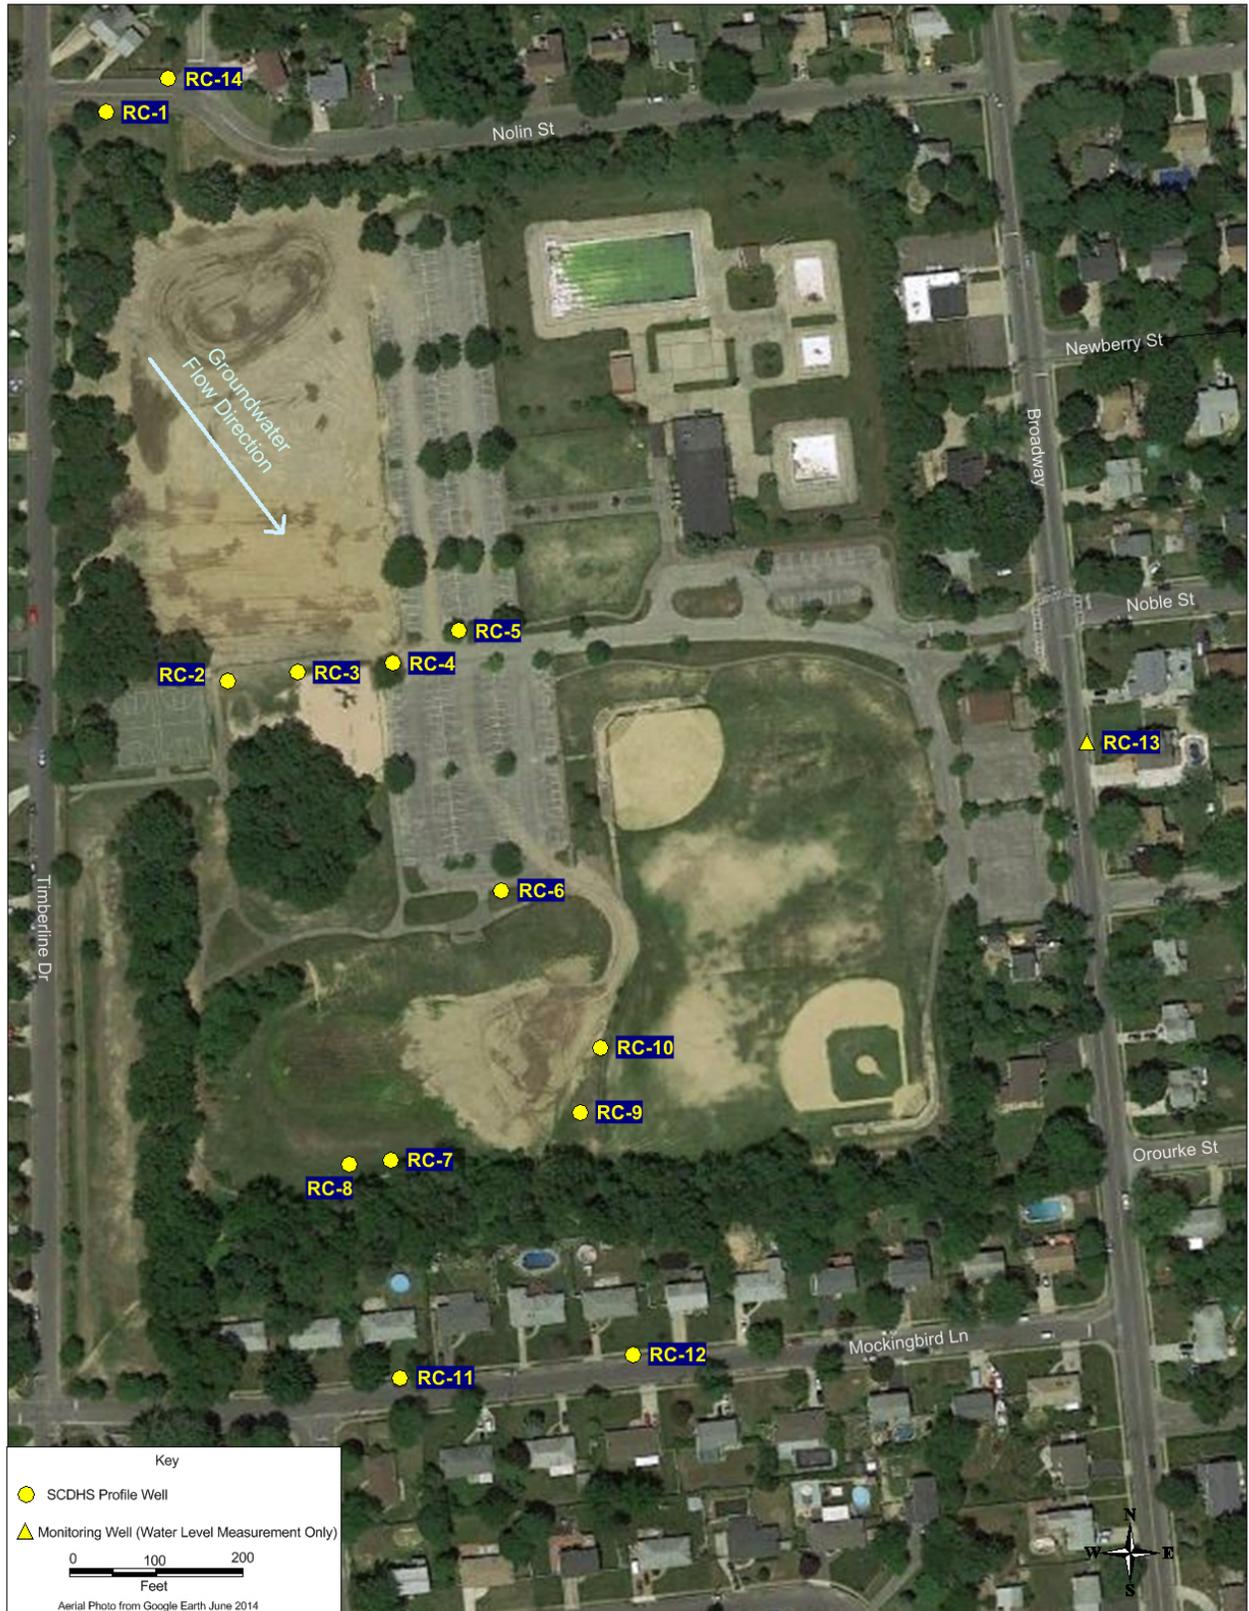
**Figure 2- Location of Suffolk County Department of Health Services Profile Wells
Roberto Clemente Park, Brentwood, NY**

The SCDHS installed fourteen wells, thirteen of which were sampled as profile wells (well RC-13 was used only for a water table elevation measurement). The monitoring wells were installed in areas relative to the location of the contaminated fill and the direction of groundwater flow (Figure 2). As noted in Table 1, wells RC-1 and RC-14 were installed off-site, upgradient of the subject site for purposes of determining the quality of the groundwater flowing onto the site. Wells RC-2 through RC-5 were installed on the subject property and downgradient of the fill located on the soccer fields. RC-6 was installed on-site, upgradient of the recharge basin and downgradient of the fill located on the soccer fields, while wells RC-7 through RC-10 were installed on-site and downgradient of the fill in the recharge basin. Finally, wells RC-11 and RC-12 were installed off-site, downgradient of the subject site, and RC-13 was installed side-gradient, east of the site, and was used for a groundwater elevation measurement and was not sampled.

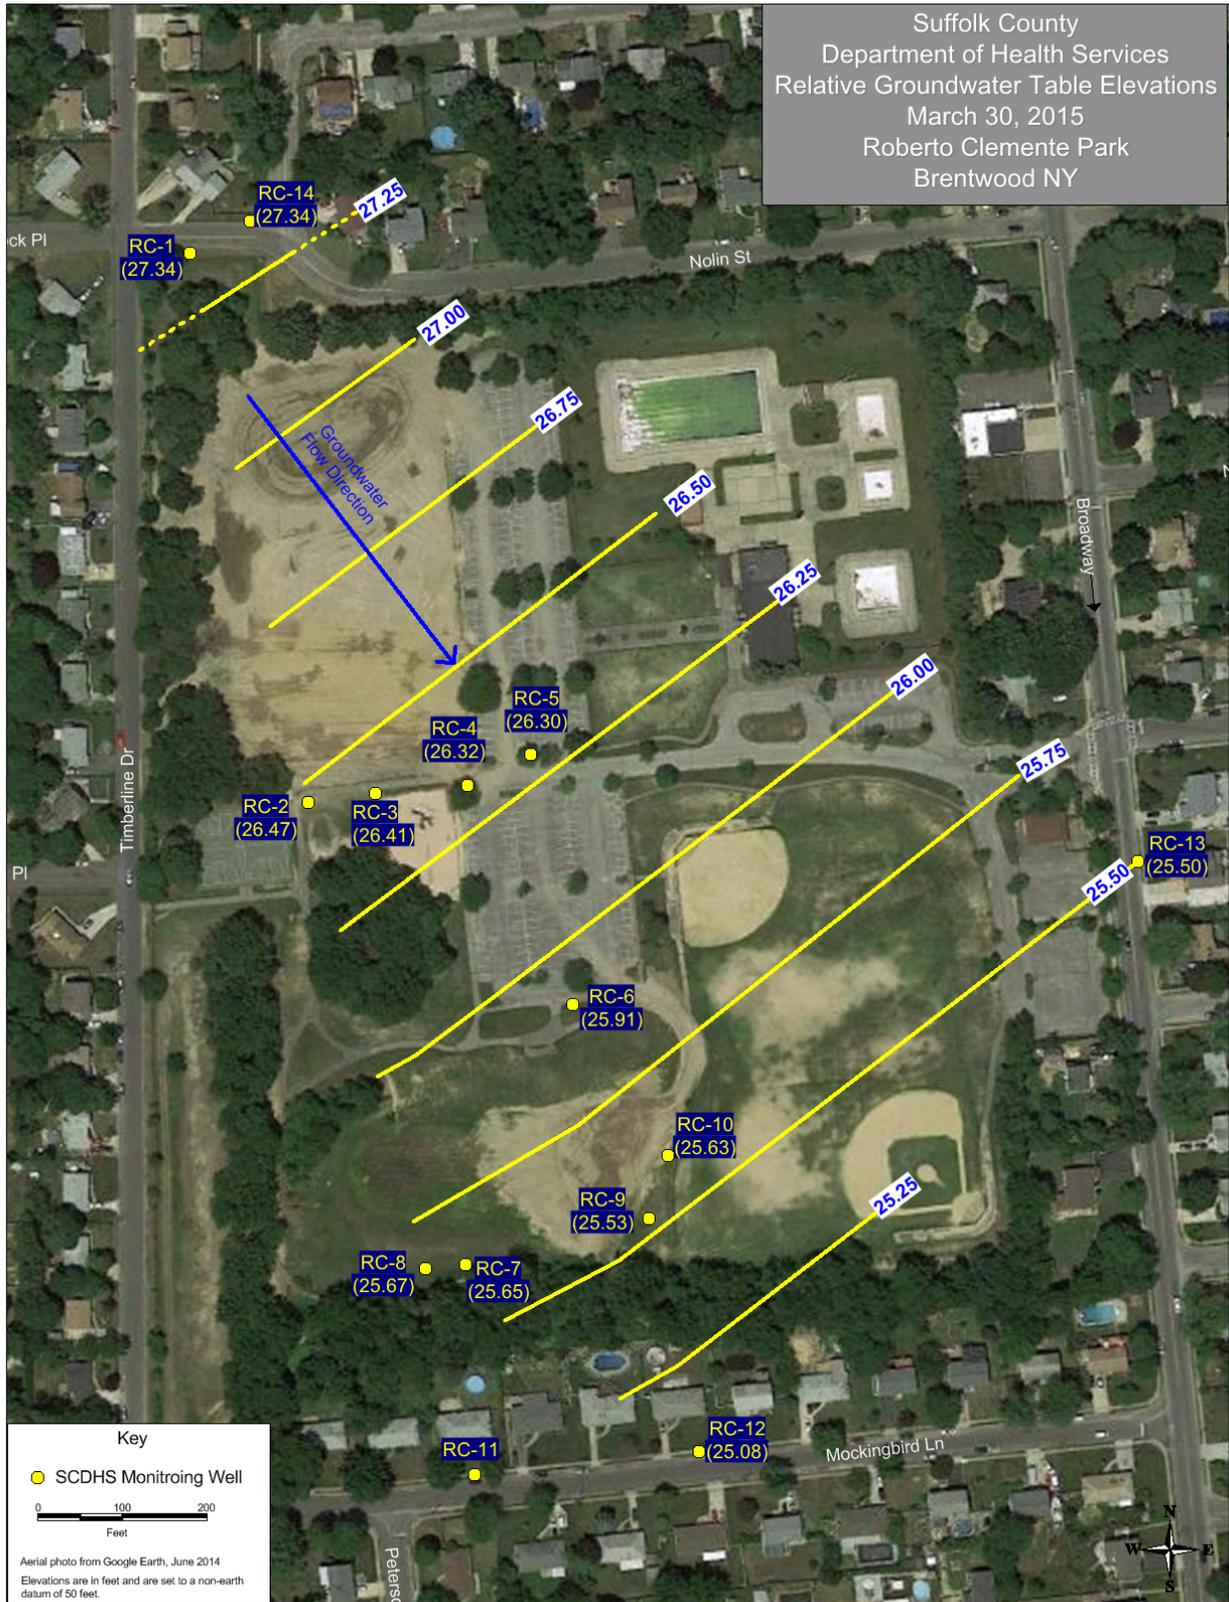
Figure 3

In order to determine a site specific groundwater flow direction, relative elevations were surveyed for thirteen of the wells (well RC-11 was not surveyed), and depth to water measurements were recorded. This information was used to produce a water table contour map (Figure 3) that illustrates the relative water table elevation across Roberto Clemente Park. Since groundwater flow is perpendicular to the groundwater elevation contour lines, this information confirms a groundwater flow southeast across the site, as indicated by the blue arrow.
