# **Robinson Duck Farm County Park Habitat Restoration Feasibility Study**

## **Park Management and Habitat Restoration Report**

**June 2010**

**Suffolk County Department of Planning**  
H. Lee Dennison Building - 4<sup>th</sup> Floor  
100 Veterans Memorial Highway  
P.O. Box 6100  
Hauppauge, New York 11788

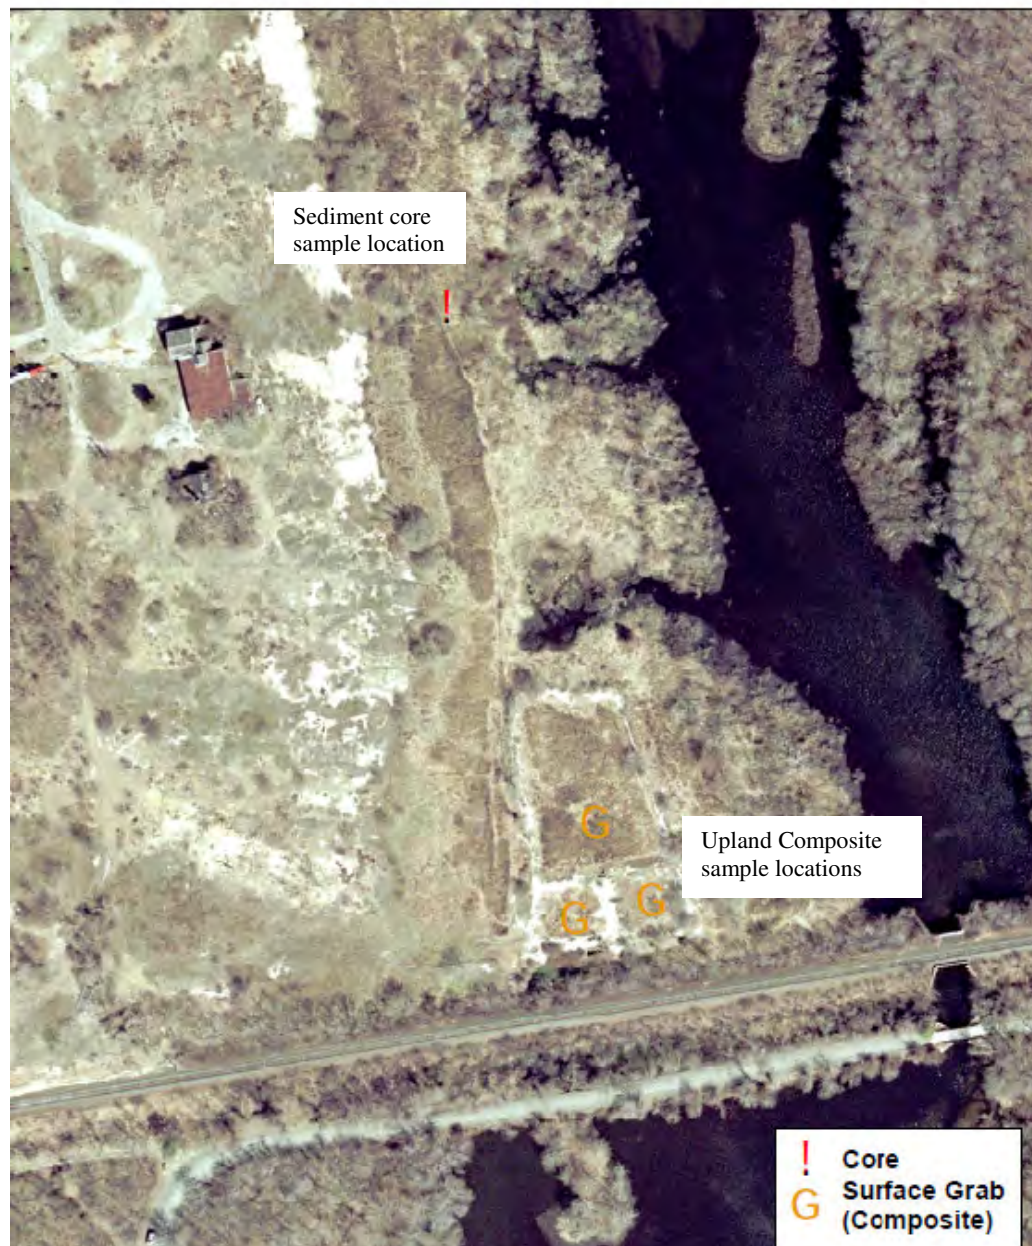
**Fig. 3-1.** Location where soil samples were collected (Army Corps of Engineers, 2009, Appendix 3).

### Robinson Duck Farm 2006 Sediment Sampling Locations

Below is a summary of the soil quality results (Army Corps of Engineers, 2009, Appendix 2).

Most striking from these soil analyses is the high levels of nitrogen and phosphorus indicating the legacy effects duck farming agriculture can have on the landscape. It should be noted that photos taken of the sampling process provided in the Army Corps report indicate that soil samples were taken during the dormant season before most vegetation was active. This might have affected levels of nitrogen and possibly phosphorus found in soils. Nitrogen and phosphorus levels in soils are known to vary widely with season, amount of precipitation, soil texture, and vegetation type.

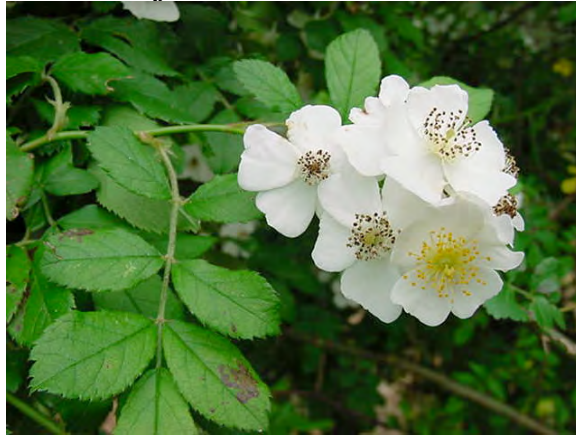
## **II. Multiflora Rose: *Rosa multiflora***

Multiflora rose (*Rosa multiflora*) is a perennial shrub with 9-12 foot long arching stems (canes) rising directly from the ground and are generously studded with stiff thorns. The leaves, which are broadly oval, less than 1-1 ½ inches long and sharply toothed, are usually made up of 7 or 9 leaflets. This shrub flowers in May or June. The fragrant white or pink flowers are in clusters, and are about ¾-1 ½ inches across with 25-100 stamens found in long or oval panicle. The fruit, which develops in late summer, are red rose hips, globular to ovoid, and somewhat fleshy. Multiflora rose (*Rosa multiflora*) endures a wide range of soil and environmental conditions, yet prefers sunny areas and well-drained soils. It reproduces by seed as well as by rooting at the tips of drooping canes. The great majority of plants develop from seeds, which

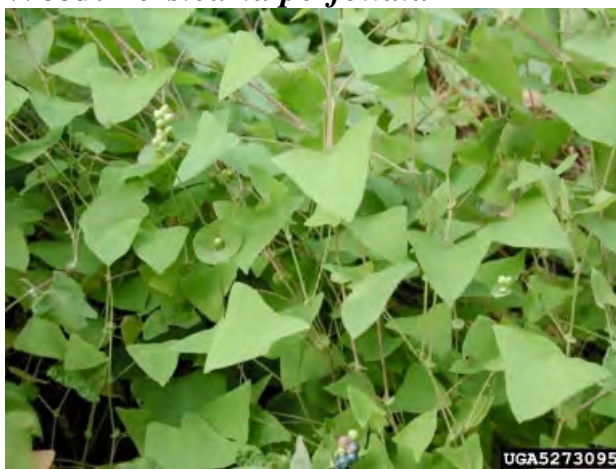
### **III. Mile-A-Minute Weed: *Persicaria perfoliata***

Mile-a-minute weed (*Persicaria perfoliata*) is an annual herbaceous, trailing vine. The stems are armed with recurved barbs which are also present on the underside of the leaf blades. Its leaves are light green in color, shaped like an equilateral (equal-sided) triangle and alternate along the narrow, delicate stems. Distinctive circular, cup-shaped leafy structures, called ocreae, surround the stem at nodes, thus the name 'perfoliatum.' Flower buds, and later flowers and fruits, emerge from within the ocreae. Flowers are small, white and generally inconspicuous. Fruits are attractive, deep blue and arranged in clusters at terminals. Each berry-like fruit contains a single glossy, black or reddish-black hard seed called an achene (NPS, 2009).

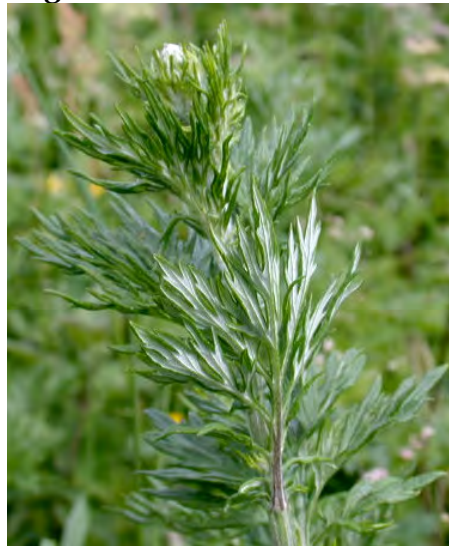
#### **IV. Mugwort: *Artemisia vulgaris***

Mugwort (*Artemisia vulgaris*) is a European weed that can grow up to 5 feet in height. Its leaves are heavily lobed, pointed, and alternately arranged along the stem. They are 2-4 inches long and 1-3 inches wide with dark green upper and covered with white hairs underneath. Flowers, which bloom in summer, are greenish, inconspicuous clusters at the ends of the stems on a spike. Mugwort is wind pollinated, but seeds are seldom viable in the Northeastern US. Reproduction also occurs by clonal growth: long white and tan roots spread out to form colonies. It usually grows in meadows, along roadsides, and in agricultural fields in open to partly shady areas (Kaufman, 2007; Bradley and Hagood, 2009).

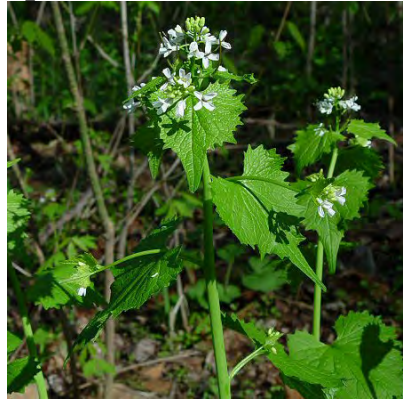
## V. Garlic Mustard: *Alliaria petiolata*

Garlic mustard (*Alliaria petiolata*) is a cool season biennial herb with stalked, triangular to heart-shaped, coarsely toothed leaves that give off an odor of garlic when crushed. It can reach from 2 to 3-½ feet in height. Its flowers are button like clusters of small white flowers, each with four petals in the shape of a cross. First-year plants appear as a rosette of green leaves close to the ground. Rosettes remain green through the winter and develop into mature flowering plants the following spring. After spending the first half of its two-year life cycle as a rosette of leaves, the plants develop rapidly the following spring into mature plants that flower, produce seed and die by late June. Depending upon conditions, the flowers either self-fertilize or are cross-pollinated by a variety of insects. A single plant can produce thousands of seeds, which scatter as much as several meters from the parent plant. Seeds can remain viable in the soil for five years or more (NPS, 2009).

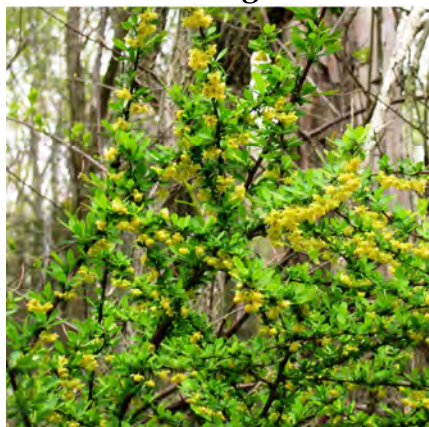
## VI. Japanese Barberry: *Berberis thunbergii*

Japanese barberry (*Berberis thunbergii*) is a dense, deciduous, spiny shrub that grows 2 to 8 feet high. Its branches are brown, deeply grooved, somewhat zig-zag in form and bear a single very sharp spine at each node. The leaves are small (½ to 1 ½ inches long), oval to spatula-shaped, green, bluish-green, or dark reddish purple. Flowering occurs from mid-April to May in the northeastern U.S. Pale yellow flowers are about ¼ in (0.6 cm) across, and hang in umbrella-shaped clusters of 2-4 flowers each along the length of the stem. The fruits are bright red berries about 1/3 in (1 cm) long that are borne on narrow stalks. They mature during late summer and fall and persist through the winter (NPS, 2009).

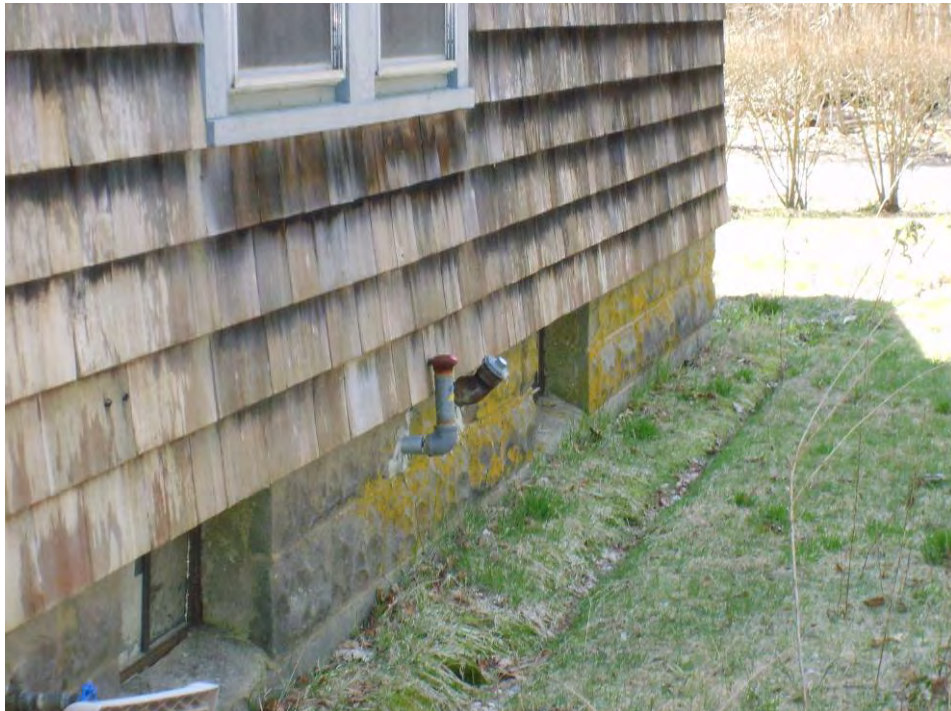
View of fuel oil tank fill and vent, typical of each of the three homes.

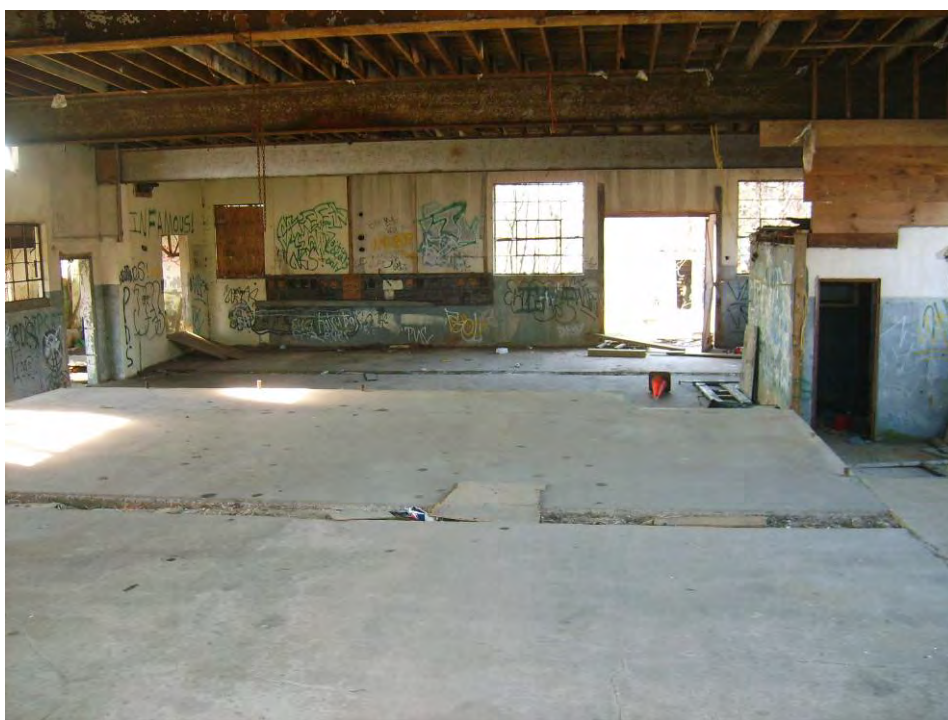
Interior view of northern farm building showing trench drains which appear to have discharged to the east.

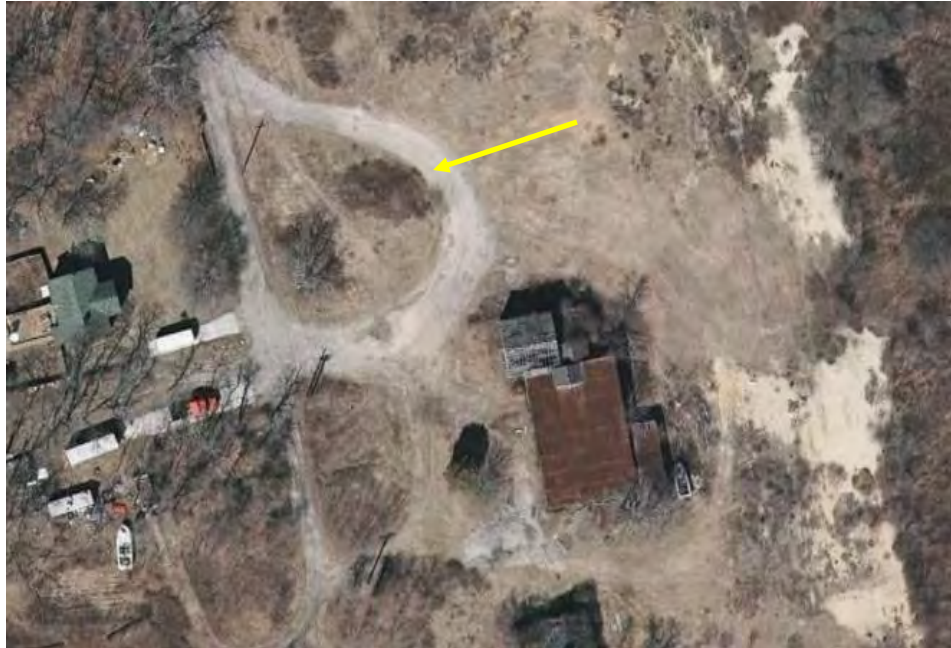
Location of suspected collapsing leaching structures located northwest of the northern farm building.

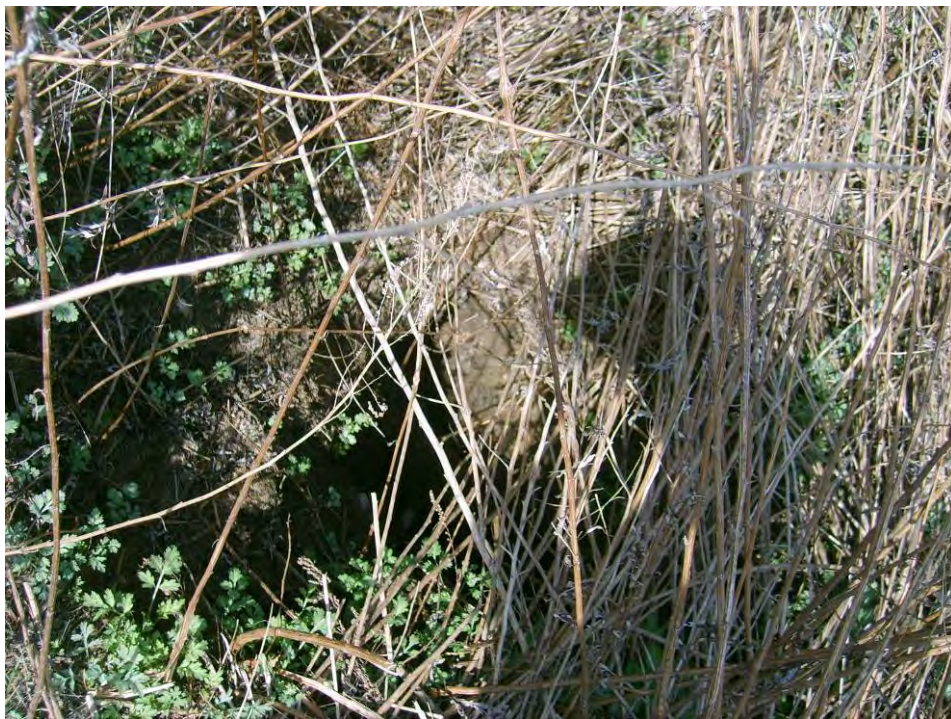
View of one of the collapsing structure which is causing a large sinkhole to form.

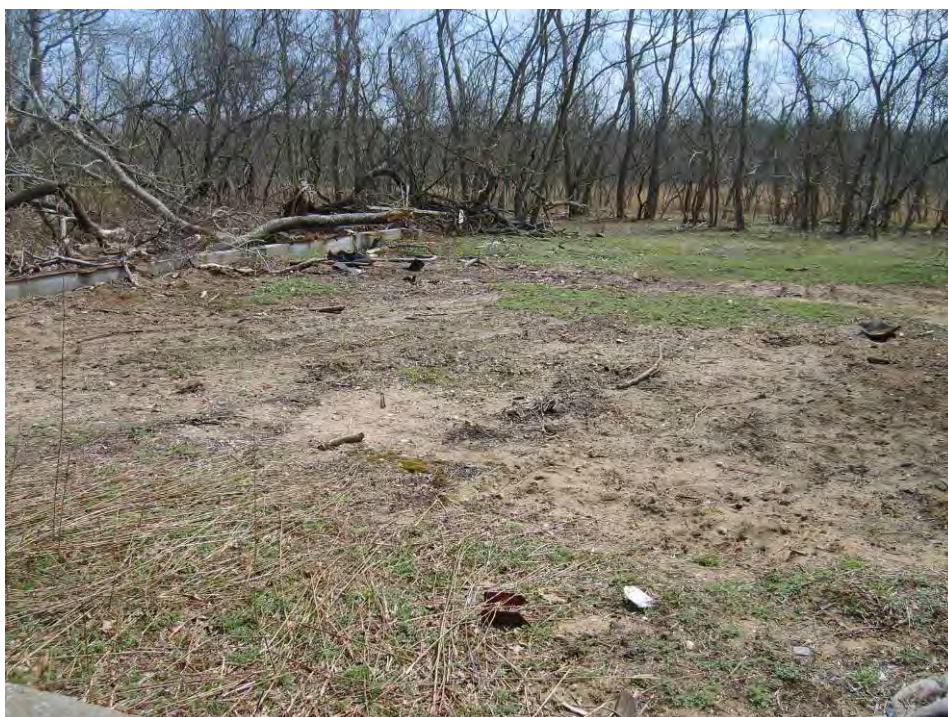
View of the former aircraft hangar area following removal of the building.

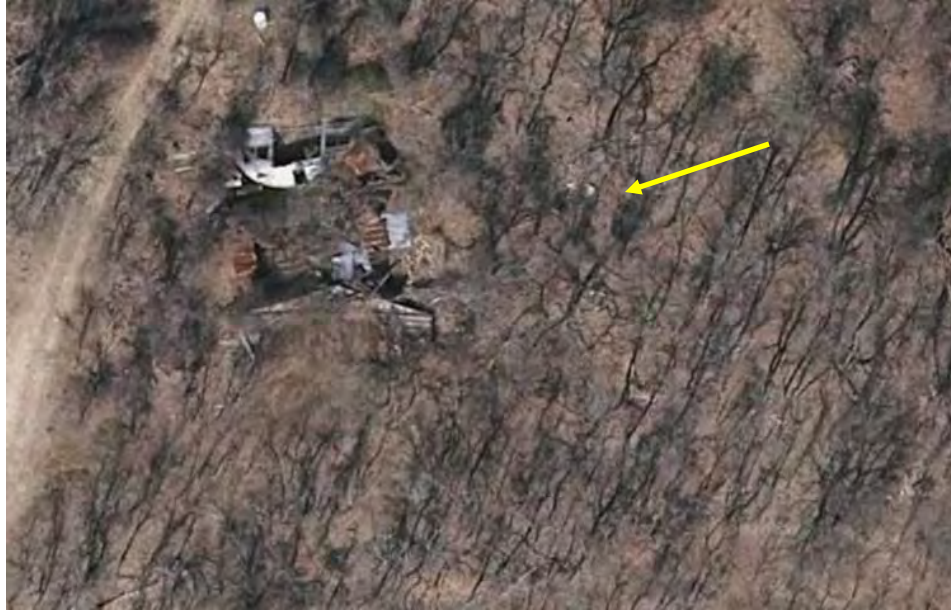
Location of the leaching pools identified east of the former hangar building.

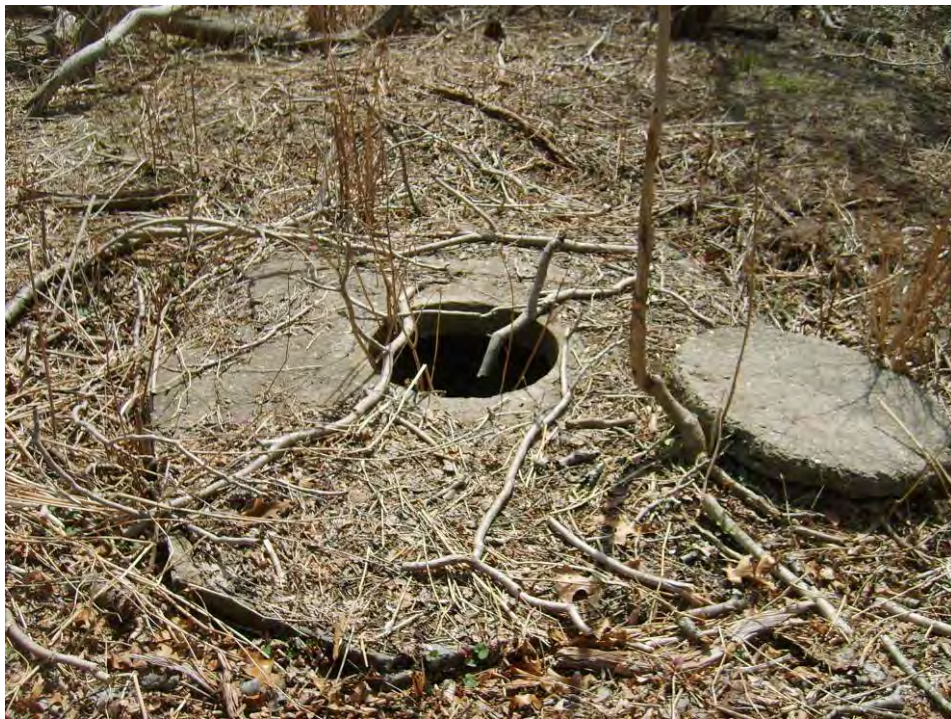
View of one of the two identified leaching pools located east of the former hangar. The other structure was of similar construction.

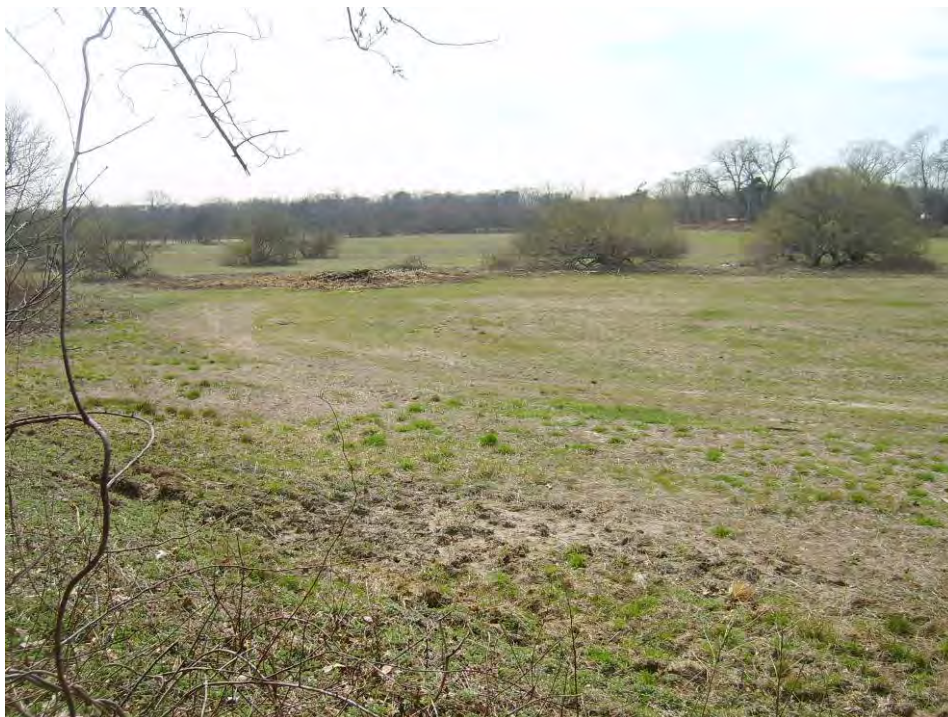
View of the former vehicle storage area. No signs of impact or soil staining were noted.

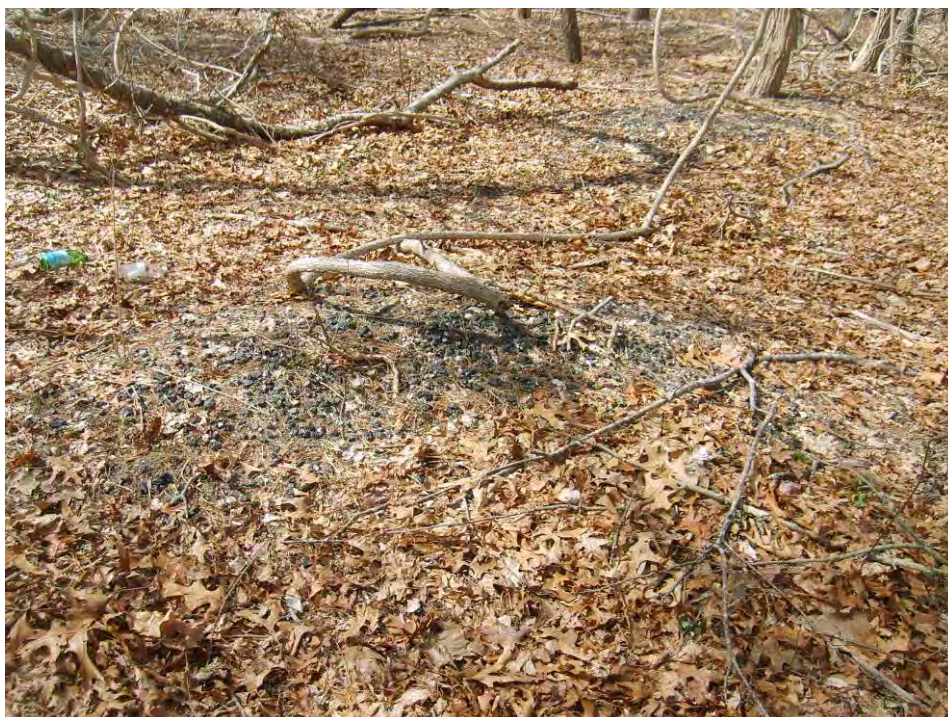
View of coal piles observed in an apparent former coal storage area.

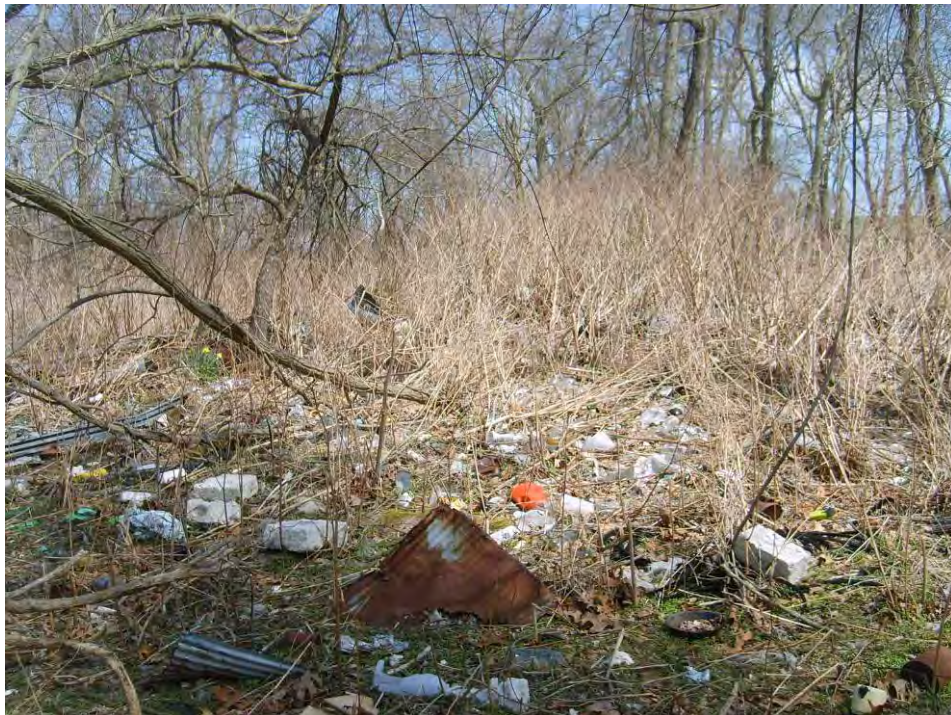
View of the western portion of the debris / trash dumping area
