### **Mud Creek Section 206 Preliminary Restoration Plan**

# Mud Creek Watershed Section 206 Aquatic Ecosystem Restoration Project

East Patchogue, Suffolk County, New York

## Preliminary Restoration Plan, Preliminary Cost Estimate & Preliminary Project Management Plan

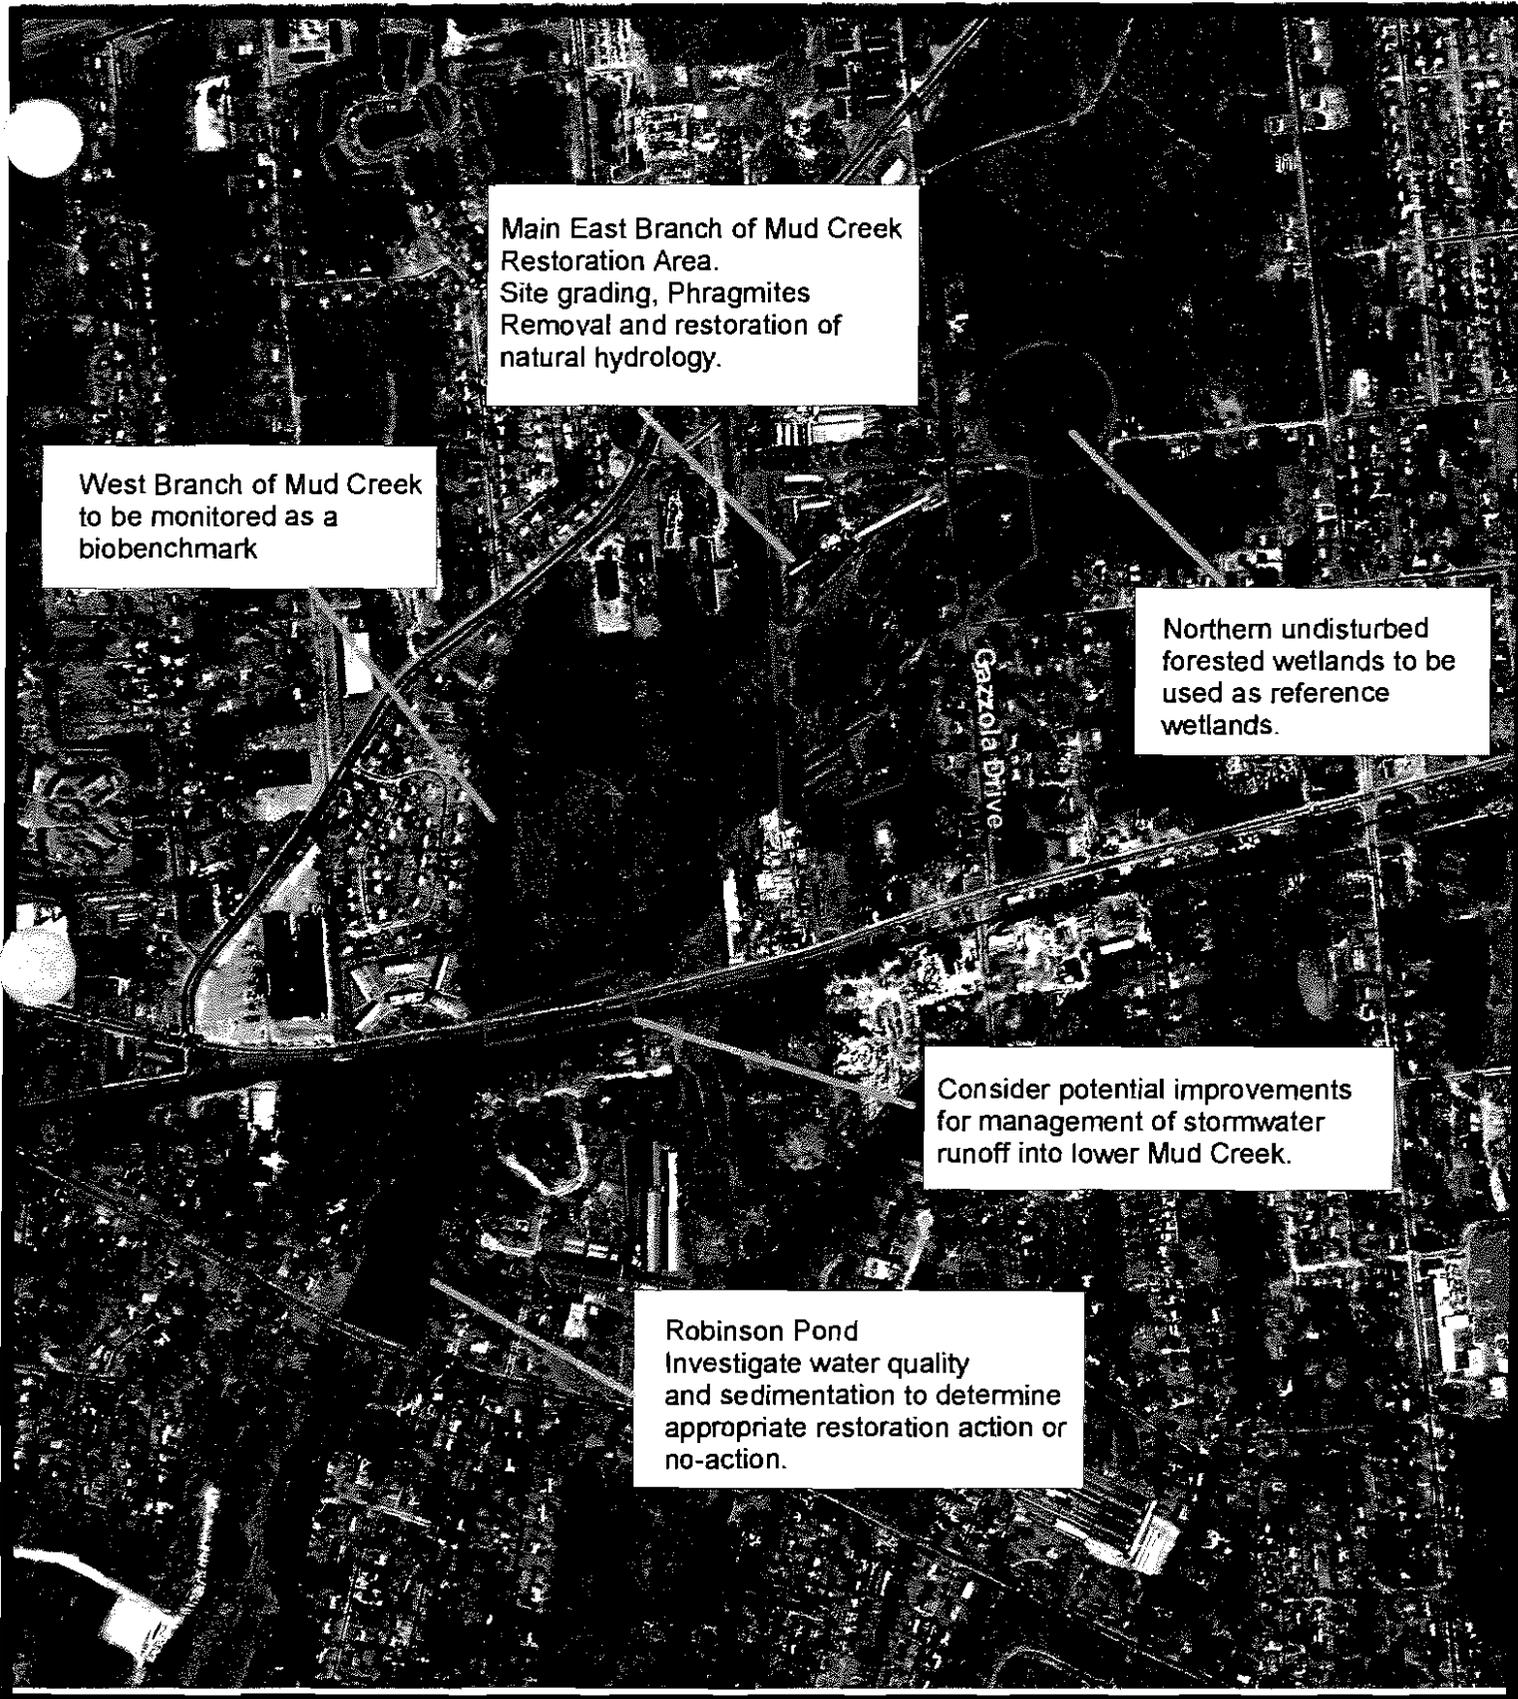
**Figure 2**

Main East Branch of Mud Creek  
Restoration Area.  
Site grading, Phragmites  
Removal and restoration of  
natural hydrology.

West Branch of Mud Creek  
to be monitored as a  
biobenchmark

Northern undisturbed  
forested wetlands to be  
used as reference  
wetlands.

Consider potential improvements  
for management of stormwater  
runoff into lower Mud Creek.

Robinson Pond  
Investigate water quality  
and sedimentation to determine  
appropriate restoration action or  
no-action.

**Overview of Mud Creek Watershed  
Restoration Areas and Reference Wetlands/Biobenchmarks**

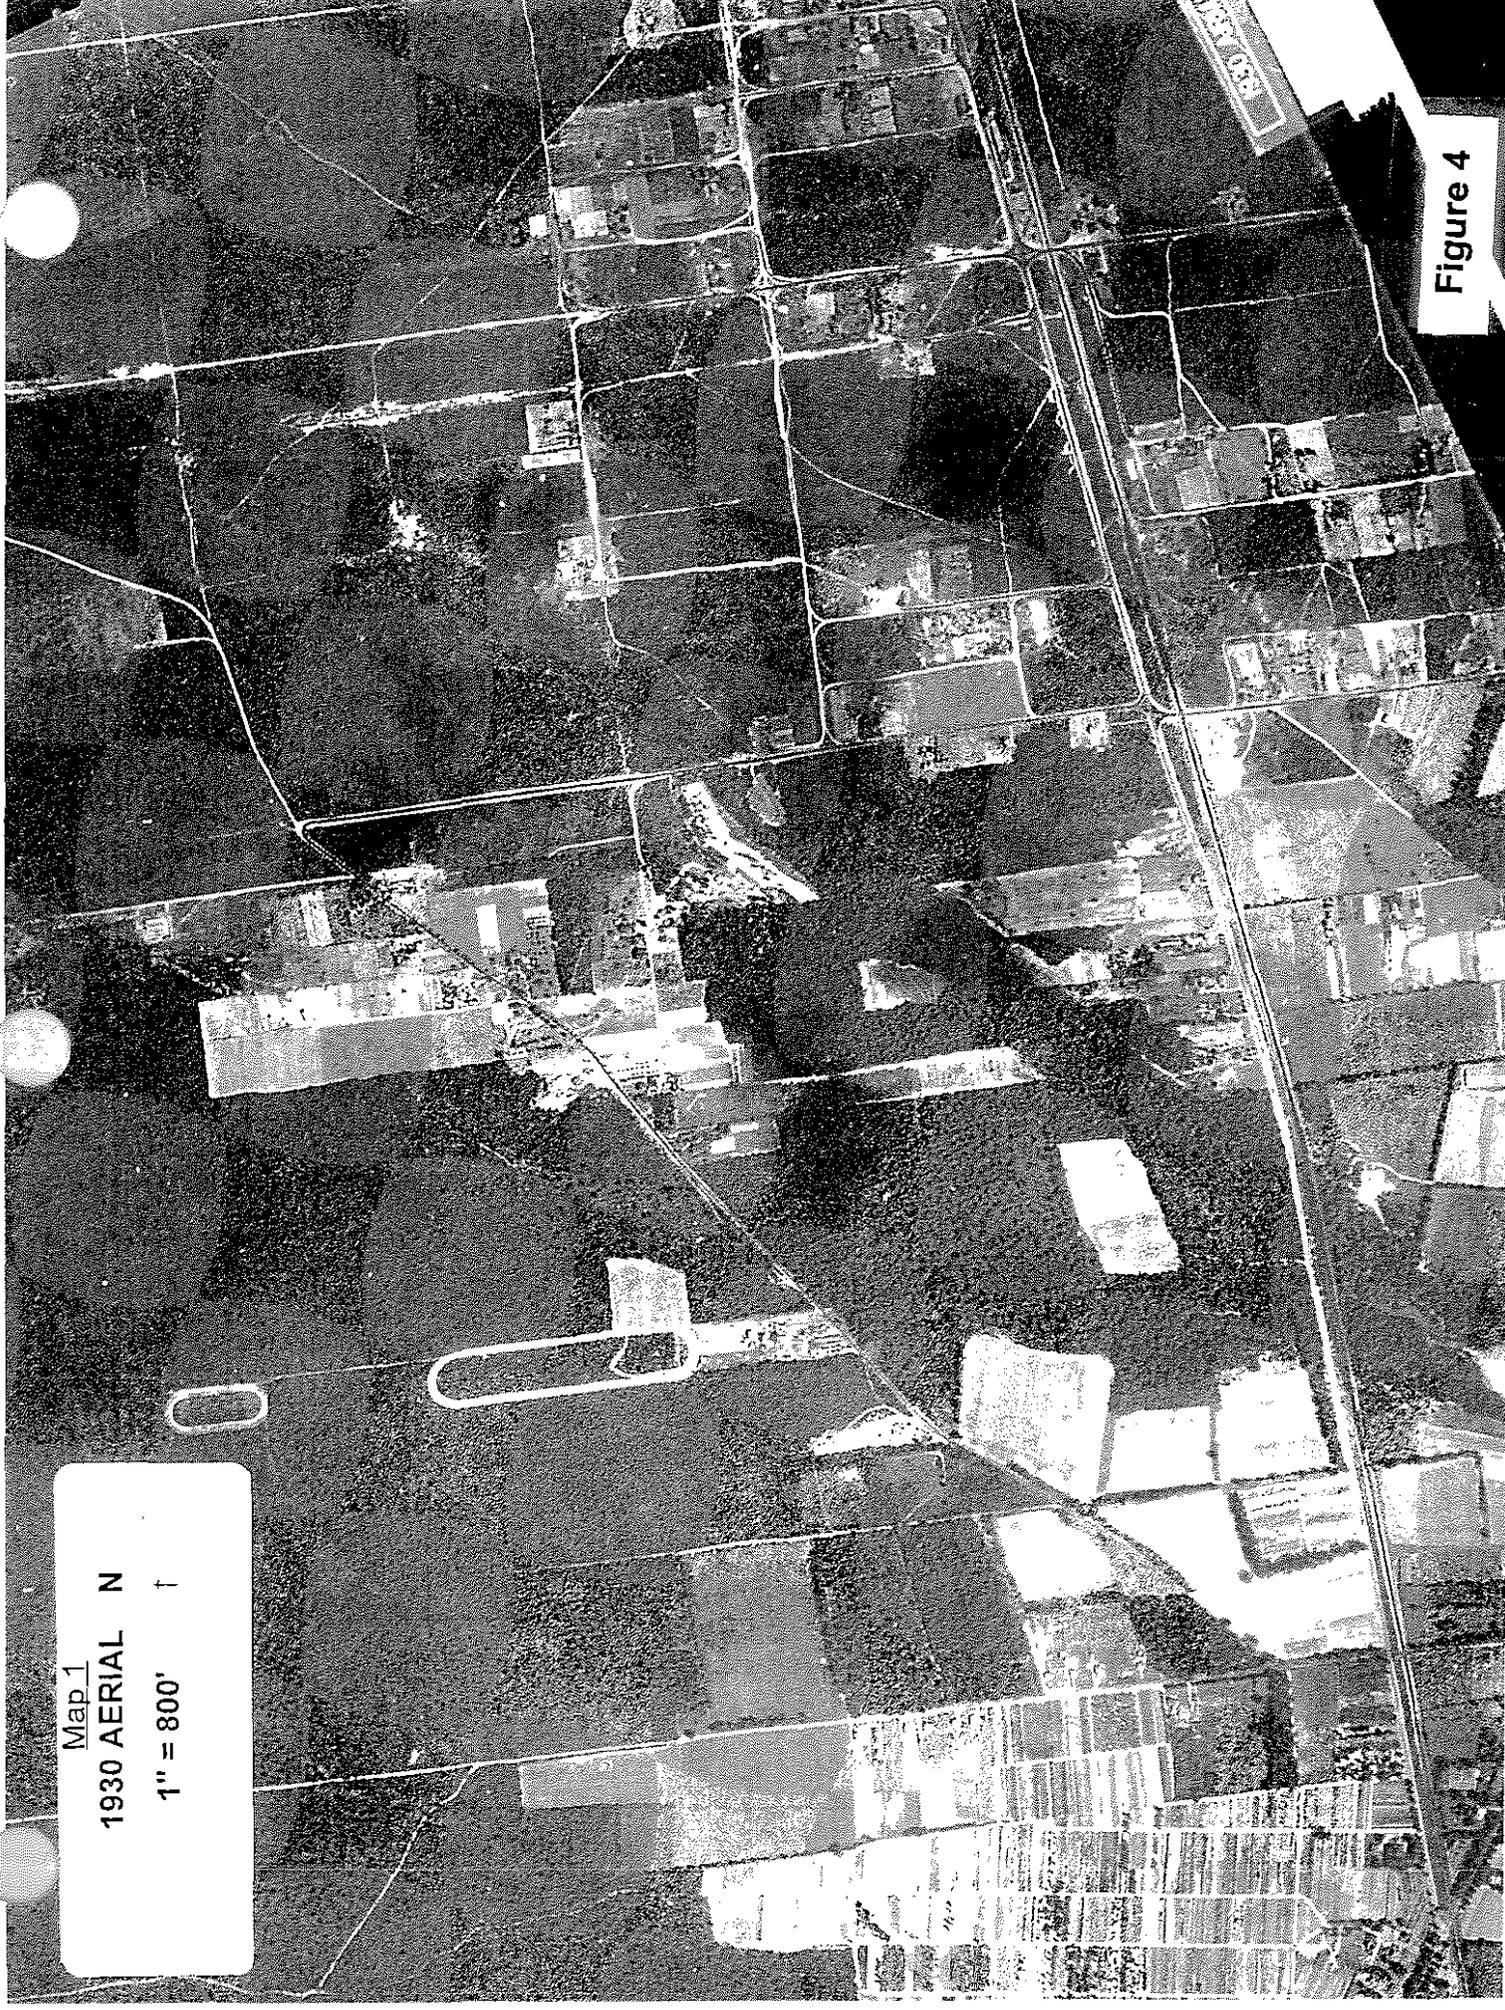
Figure 4

Map 1  
1930 AERIAL N  
1" = 800'

The development of the Gallo Duck Farm over time is illustrated through the series of aerial photographs available for the area dated 1930, 1966 and 1999 (Figures 4-6). As seen from the 1999 aerial, the lagoon and settling pits created as part of the Conservation Plan, and many of the now dilapidated farm buildings and structures are still in place today at the site. Prior to the implementation of the Conservation Plan, it is speculated that the topography of the farm site was altered through grading and use of fill material. The duck farm property was acquired by Suffolk County through the County tax lien procedures and transferred to the Suffolk County Department of Parks, Recreation and Conservation in 2001. The streambed is currently dominated by *Phragmites australis* and water quality is impaired through improper hydrologic connection, creating stagnant water through the stream and the detention ponds formed in the old swimwater areas. The local sponsor, Suffolk County, has the objectives of restoration of the environmental quality of the site and to potentially utilize the site as a passive recreation area.

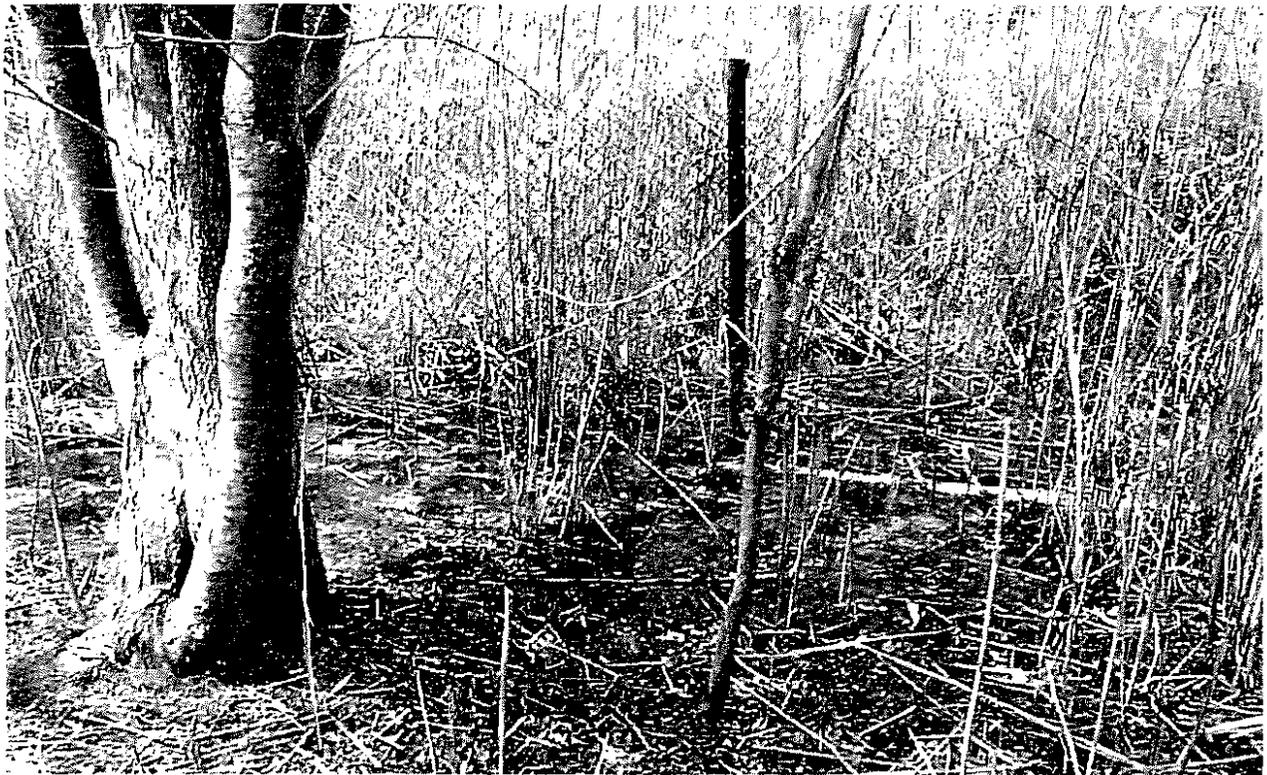
Stagnant water portion of Mud Creek at abandoned duck farm.

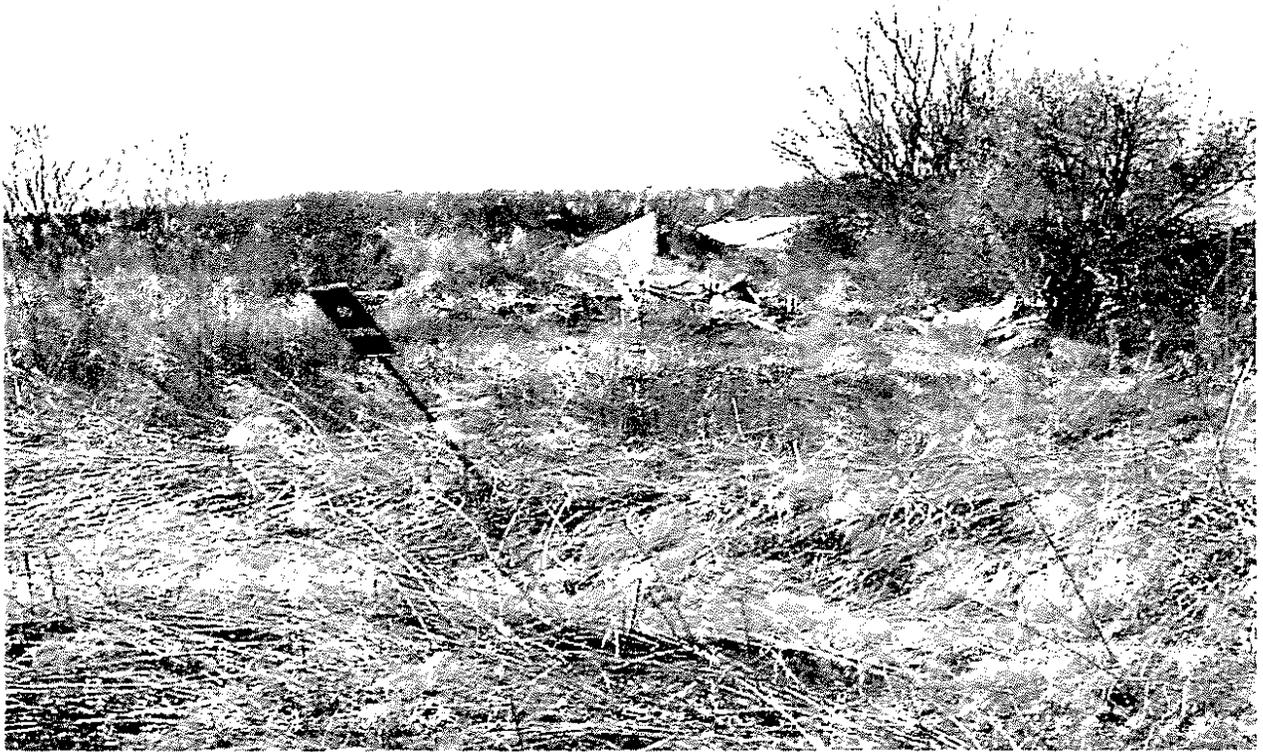
Dilapidated farm buildings on former duck farm west of Gazzola Drive.

Both of the alternatives for the restoration area west of Gazzola Drive would include removal of old pipe, concrete culvert and selected farm structures.

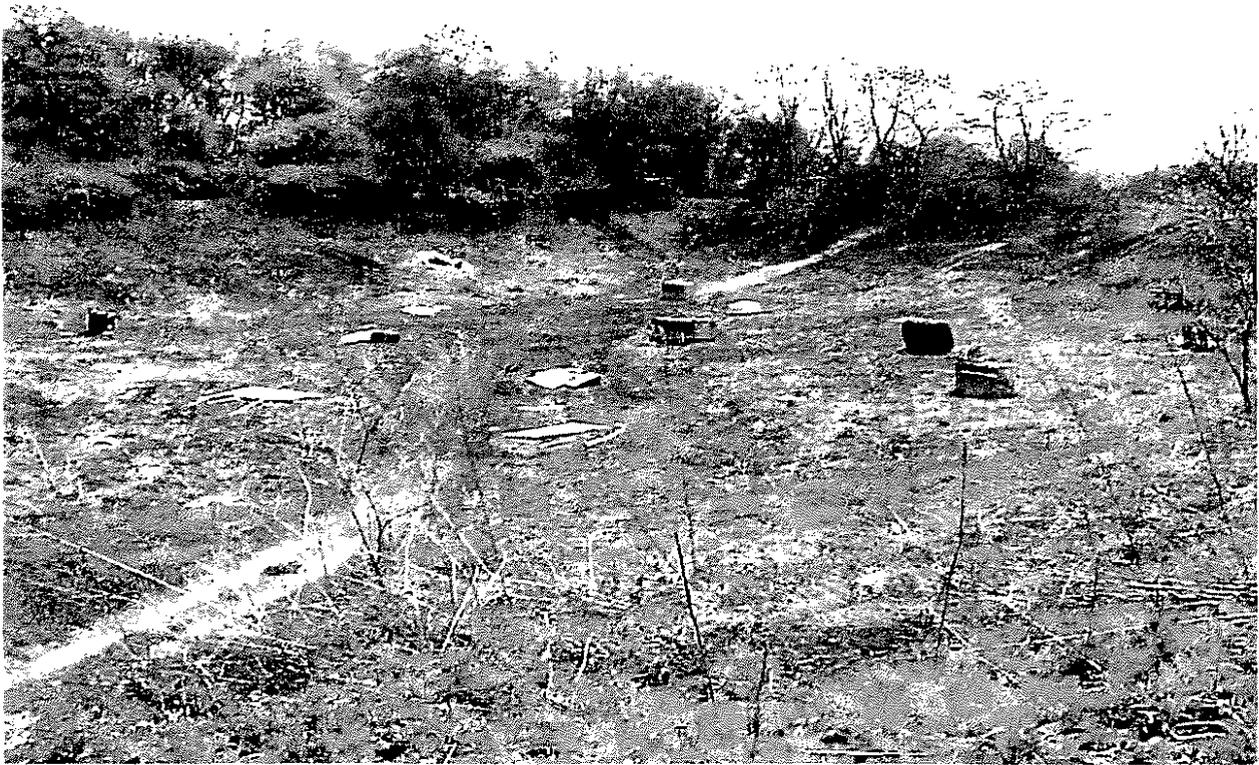
Former duck farm waste disposal lagoon.

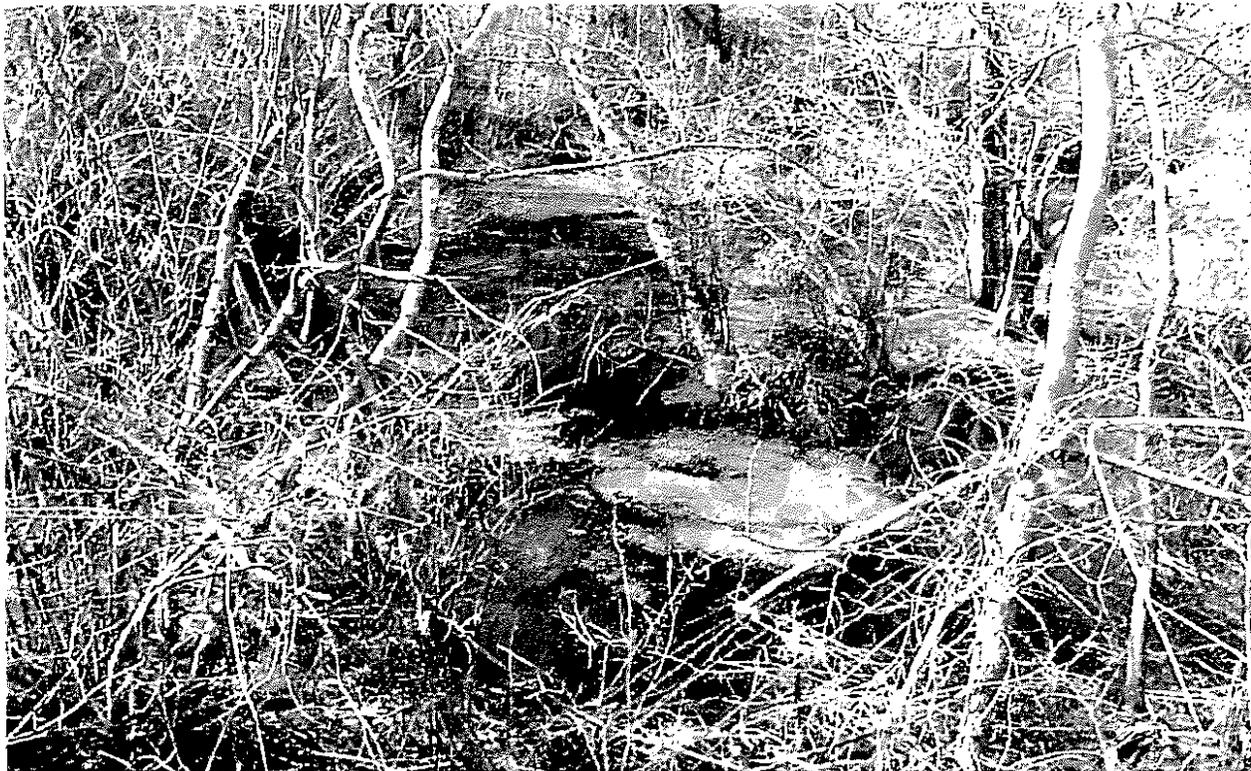
Undisturbed portion of Mud Creek between former duck farm and Montauk Highway.
