Potential Gallo Duck Farm Restoration Area

MUD CREEK WATERSHED AQUATIC ECOSYSTEM RESTORATION FEASIBILITY STUDY

East Patchogue, Suffolk County, New York

April 2013

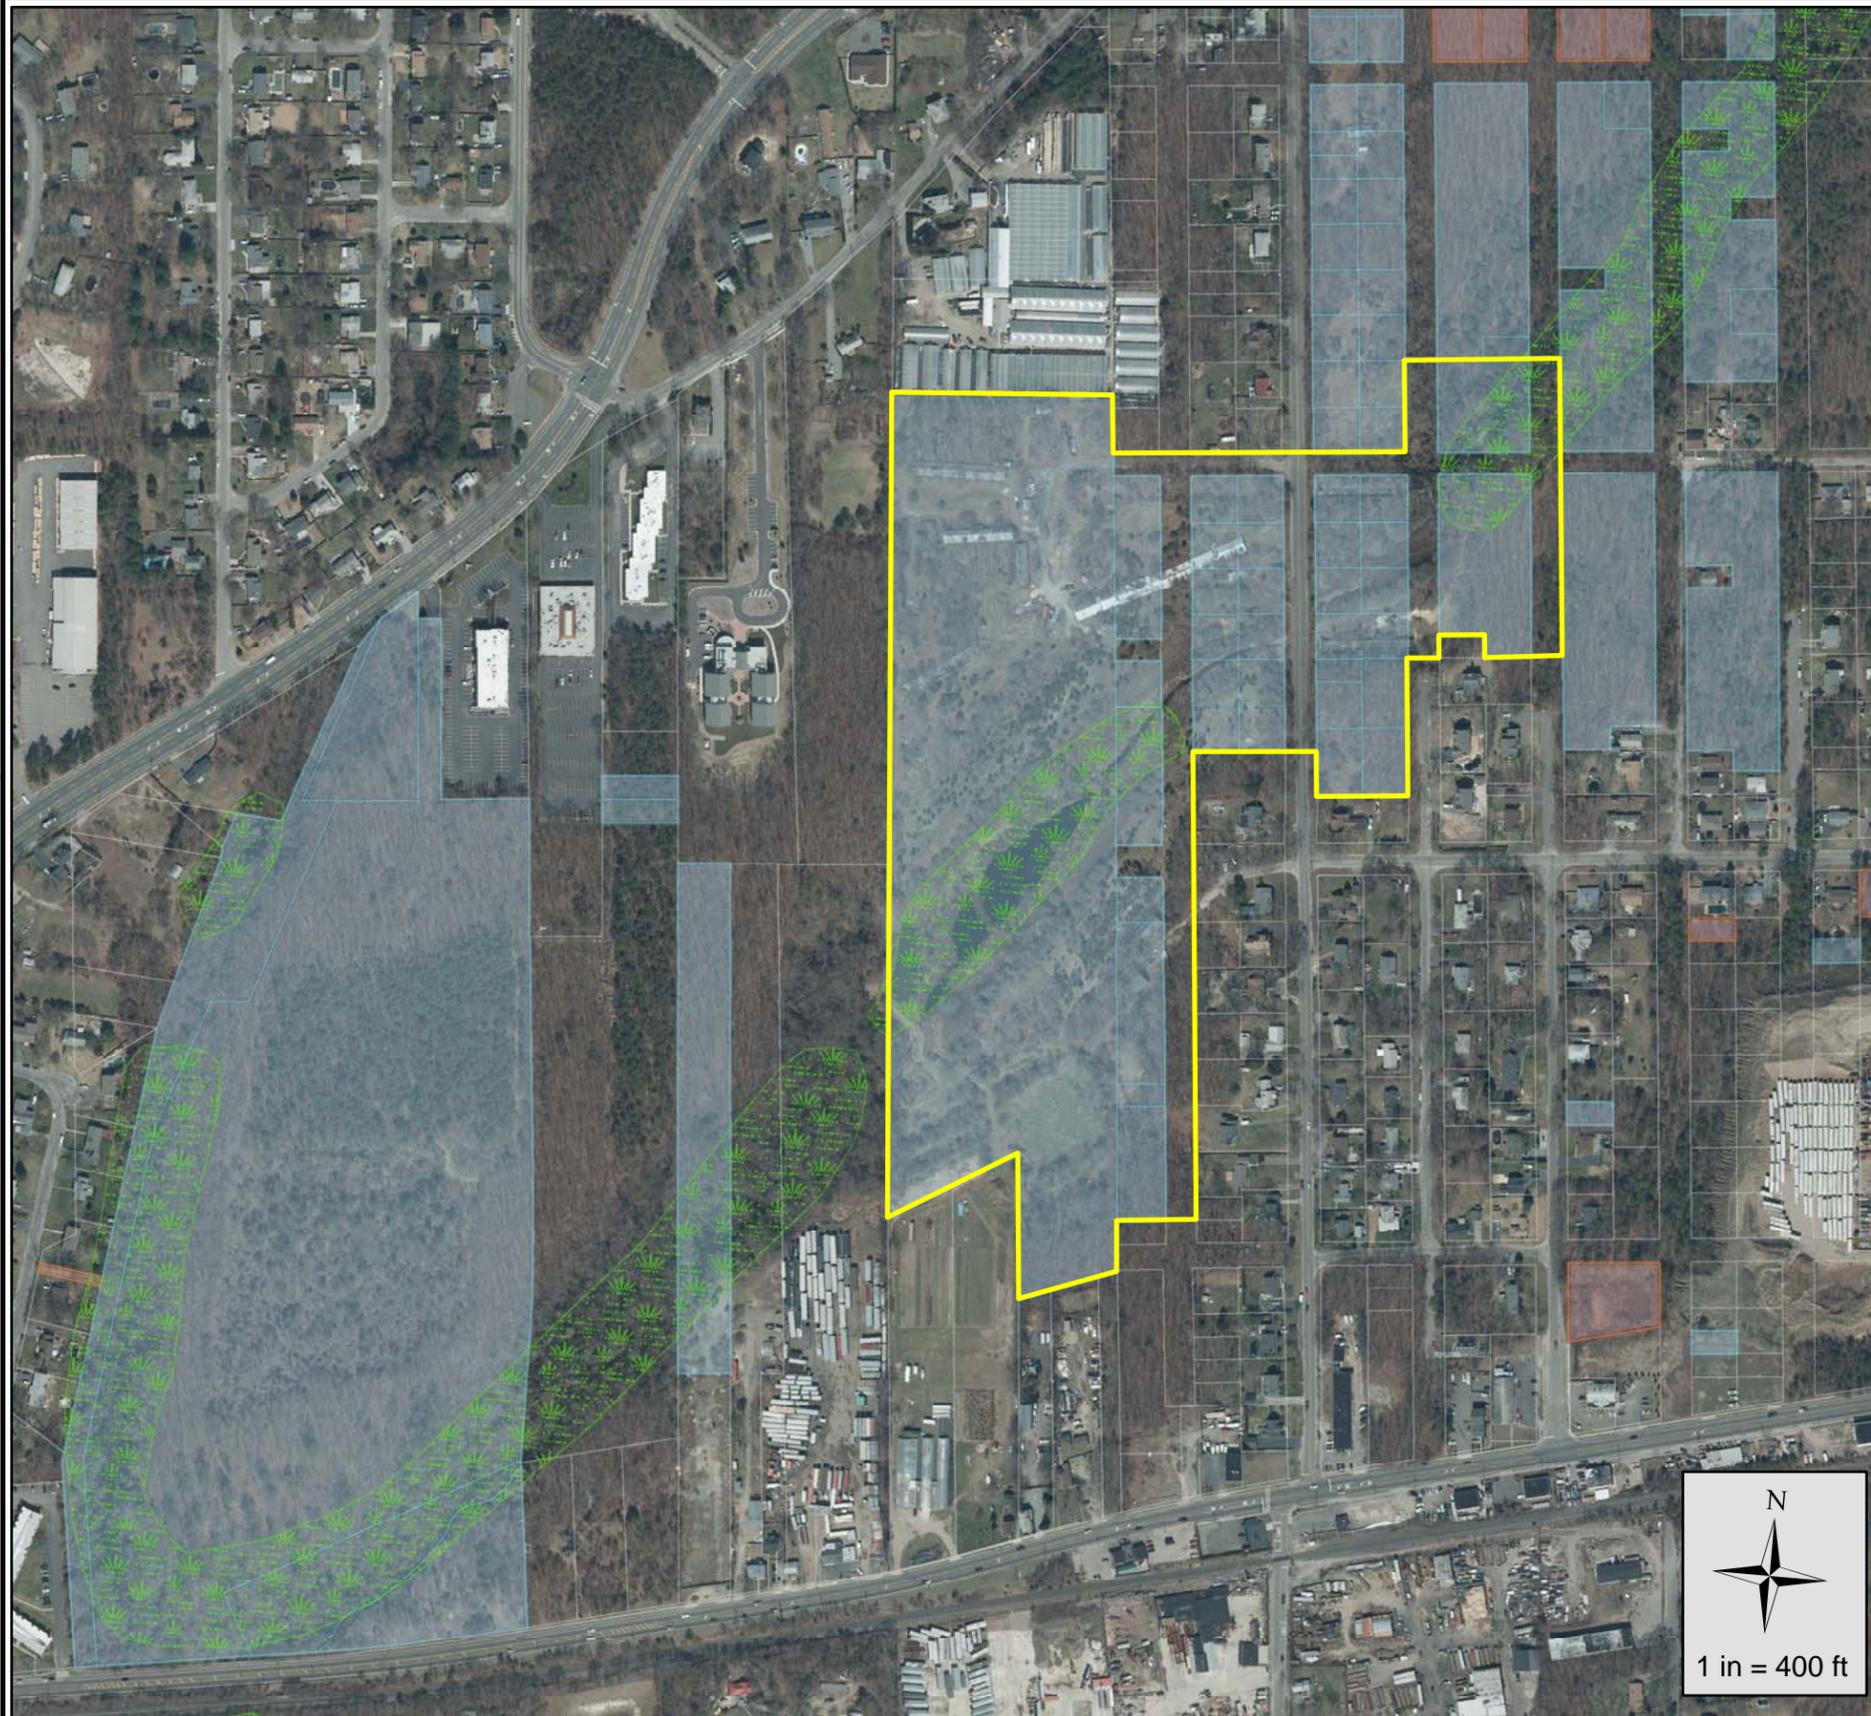
- This map depicts areas where active restoration actions would likely be recommended to remove adverse ecological conditions from historical duck farming including, but not limited to, demolition of structures, excavation and grading, invasive plant control, and stream and wetland restoration.
- Data Sources:
NYSDEC Freshwater Wetland information courtesy of CUGIR, NYSDEC.
Parcel information Copyright 2012, County of Suffolk (NY). Real Property Tax Map parcel lines used with permission of Suffolk County Real Property Tax Service Agency.
2010 orthoimage courtesy of NYSITS (www.gis.ny.gov).
- This publication is funded by the County of Suffolk under CP #8710.110.
